CORROSION AND STRUCTURAL
INSPECTION OF AN INTERNAL
REINFORCED CONCRETE ELEMENT
LOCATED AT CHAINAGE 0+145 IN
THE SAN ROQUE UNDERGROUND
CULVERTS-ARCH, IN TUXTLA
GUTIERREZ, CHIAPAS

FACULTY OF ENGINEERING, UNIVERSIDAD AUTÓNOMA DE CHIAPAS, MÉXICO.

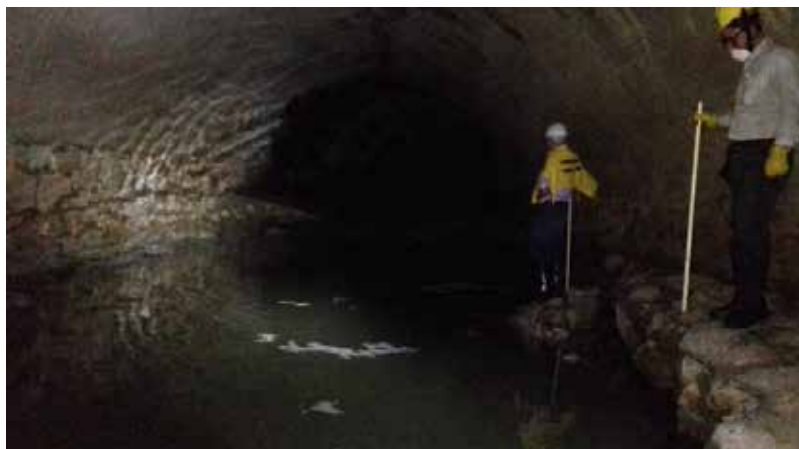
Figure 2. Black water flowing through the "San Roque Underground culverts-arch"

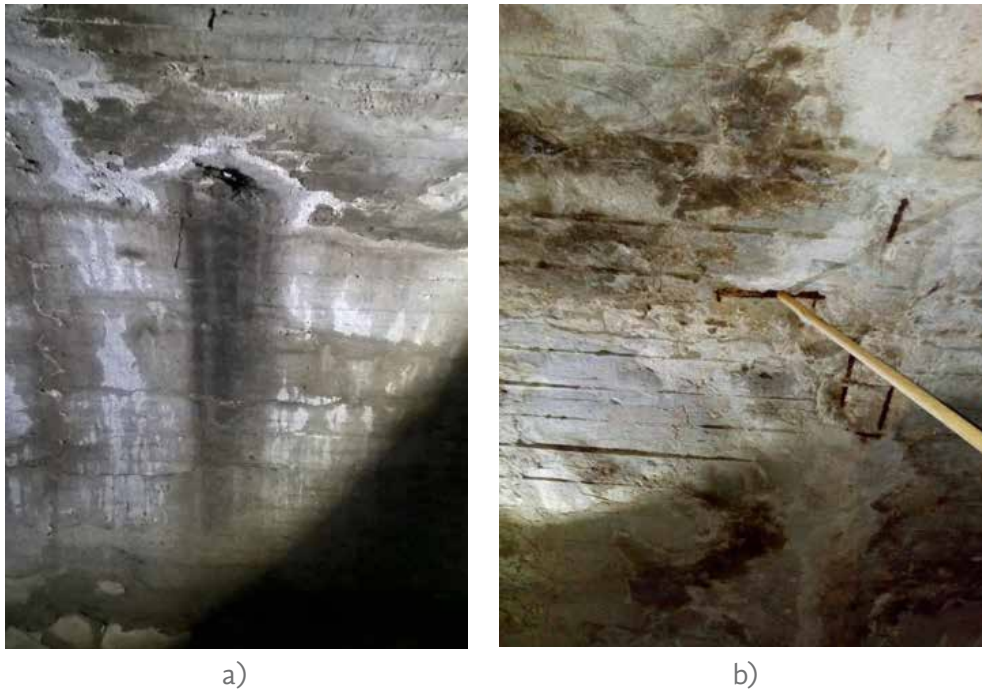
The infiltration through cracks, crevices and voids in the underground culverts-arch internal protection (reinforced concrete lining) were observed, causing staining, efflorescence and leaching of calcium hydroxide and other components, which are dispersed over the sides of the concrete surface (Figure 3a). The steel reinforcement of the concrete, both longitudinal and transversal, shows visible corrosion, clearly exposed, with detachment of materials typical of the lining zone and crystallized alkaline leachates, as can be seen on the chainage 0+568 (Figure 3b).

Figure 3. Material degradation of the “San Roque underground culverts-arch” structure (Mundo, 2019)

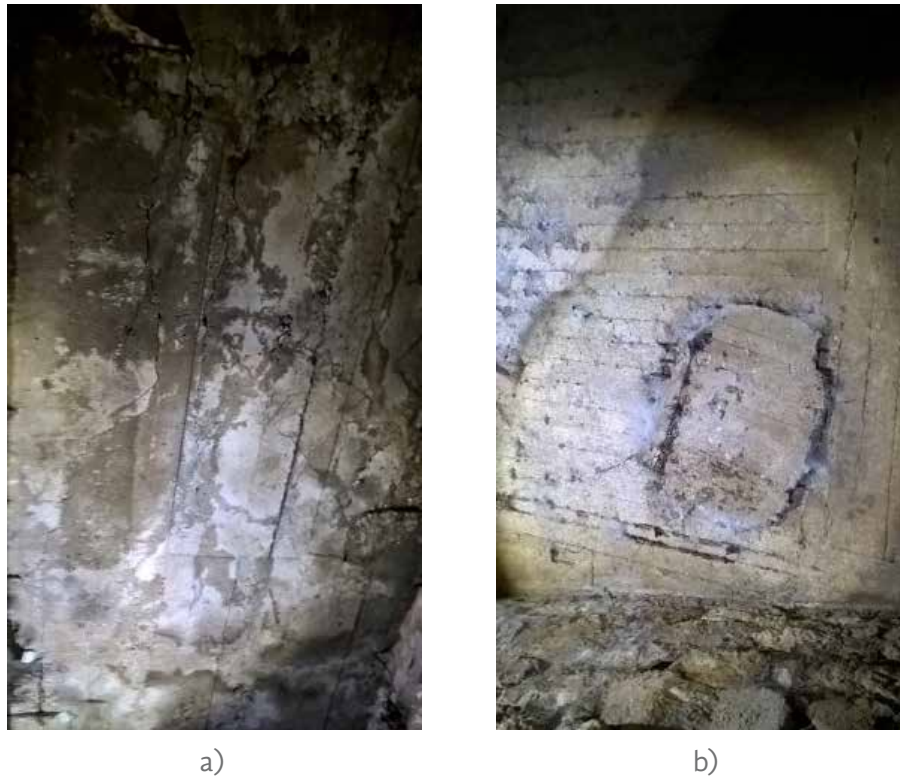
In the reinforced concrete (RC) system, beams and slabs, located at the chainage 0+145, various undesirable structural aspects were observed, such as: a) exposure of longitudinal and transverse steel reinforcement, b) partial longitudinal cracking (Figures 4a) and bursting shown in Figure 4b, highlighted in a blue box. It was observed that, in this last damage zone located in the slab structure, maintenance work had already been carried out (unknown dates of execution). However, it was noted that the construction process used in such maintenance is of low quality, as shown in Figure 4b. Lack of adequate maintenance is evident and therefore, there are notorious material failures such as cracking and detachments in several sections of the RC slab.

Figure 4. Material failures: (a). Cracking and (b). Slab bursting

The concrete patch observed in Figure 4b (blue square) corresponds to blowout damage, generally caused by reactive aggregates and cement that are high in alkalis, or in its case, by aggregates that expands when is in constant contact with water or humidity. In this case, it is a severe burst that has been repaired, since the damage diameter is greater than 5 cm and depth greater than 2.5 cm (Carmona, 2003).

Cracks located on the analyzed slab lower surface, in chainage 0+145, are structural damage caused by dead and live loads, ranging from strong to severe cracking, with cracks from 0.6 mm and larger than 1 mm wide.

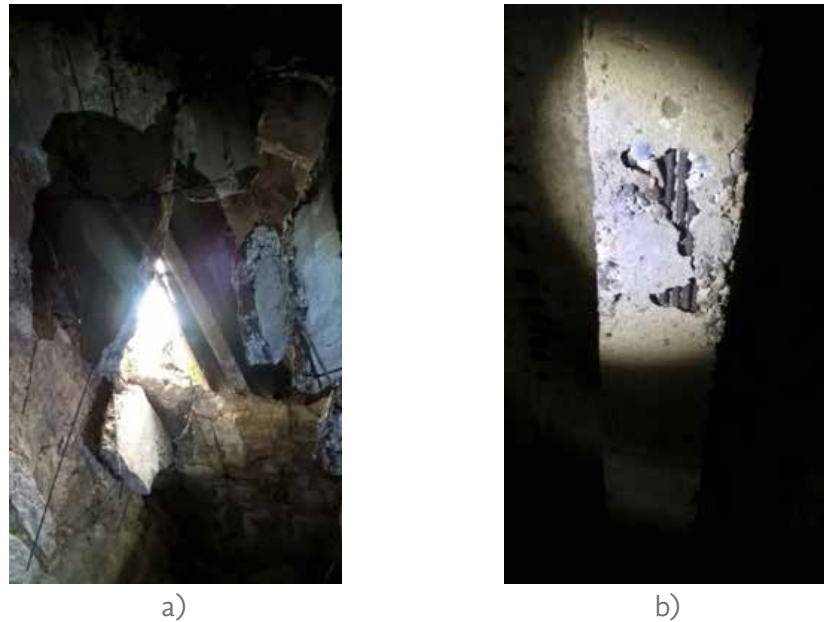
A relevant aspect of the inspection was the identification of a collapsed area of the reinforced concrete structure, located at chainage 0+145, as shown in Figure 5a. In this collapsed section, the severe deterioration due to corrosion of the steel reinforcement and the concrete degradation can be observed. In addition, problems were observed in reinforced concrete beams that have never received maintenance, presenting areas without concrete cover on the bottom side of the element, exposing the steel reinforcement and, therefore, with an active process of generalized corrosion. Moreover, concrete segregation was observed in beams, because the material used as coarse aggregate in the construction process is either from boulder or from river (Figure 5b).

Figure 5. a). Slab collapse and b). Areas without concrete cover and with visible concrete segregation in beams of the RC structure

Associated to the longitudinal steel reinforcement deterioration, in some cases, rods' corrugations tend to disappear (Figures 5, 6 and 7), so there is also a deterioration in the bond capacity with surrounding concrete (debonding), which could lead to considerable cracking in the presence of extreme actions or even under normal service conditions, as commented by Vidal *et al.* (2007). Bond strength degradation could increase in those sections where, due to the corrosion effects, a lack of effective transverse steel reinforcement for confinement is developed (Fang *et al.*, 2004). As indicated in this section, the structural properties of the elements, such as flexural stiffness, shear and flexural strength, can be degraded with the increase of the corrosion levels, due to the steel reinforcement deterioration (caused by the respective induced concrete spalling), since such properties are in function of the amount of longitudinal (the tensile reinforcement ratio, relationship between the tensile and compression reinforcement ratio) and transverse steel reinforcement (stirrups), the resisting effective concrete cross-section area, as well as bond strength between steel and concrete (e.g. Vidal *et al.*, 2007, Xia *et al.*, 2011, Godínez *et al.*, 2019).

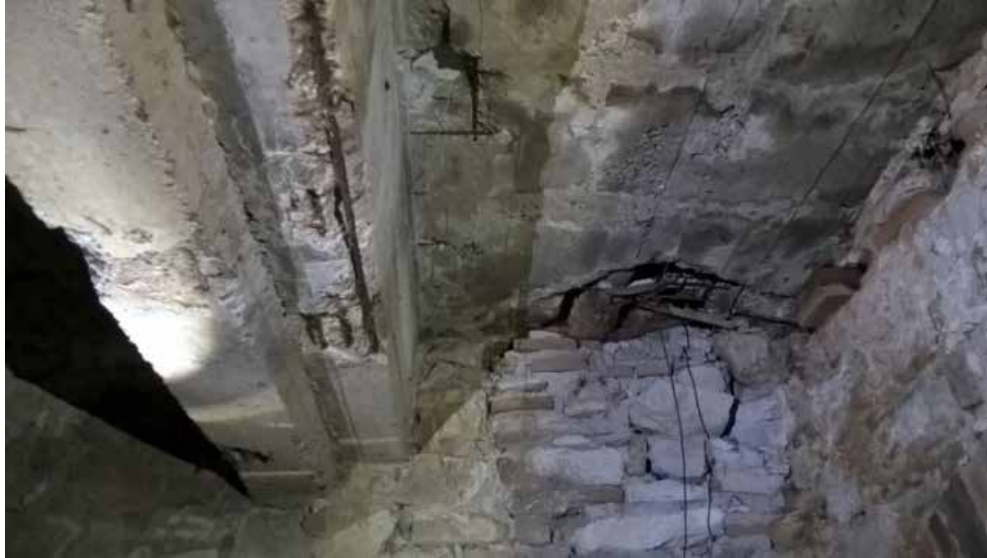
In general, this section of the structure has no conservation and a serious material deterioration process. Various pathologies were observed, both in longitudinal beams, as well as in the reinforced concrete slab (Figure 6), where there are problems of spalling, delamination, segregation, bursting, efflorescence, filtration, humidity, leaching, little or complete lack of the concrete covering for the steel reinforcement and, with light to severe electrochemical corrosion. The latter, is a phenomenon that is due to the action of electrochemical batteries, where metal (steel reinforcement) suffers dissolution in anodic regions, without attacking the cathodic regions, not affecting equally all the metallic surface that are in contact with electrolytic conductivity systems, where the presence of water molecules on the material surface is necessary for this deterioration to occur (Otero, 2001), producing in visible anodic areas, partial or total loss of the bottom longitudinal steel reinforcement (Figure 6, 7a and 7b). In this area, the use of inadequate construction process techniques, lack of quality control of materials and little or no supervision provided is also visible.

Figure 6. General view of slabs and beams with various pathologies

As commented, all points illustrated above (Figures 3 to 7), could represent important structural risks, as it is known and it has been illustrated (Figures 6 and 7), corrosion can deteriorate steel reinforcement to such a degree that it practically disappears. In such cases, there may be a significant reduction of the flexure and shear strength of individual structural elements. This is due to the fact that when stirrups (and longitudinal steel) corrode, they are no longer useful and the elements' failure mechanism can be modified, instead of having a behavior governed by flexure (assumed at the design stage), as is desirable, premature and sudden shear failures can occur, which is totally undesirable. In addition, in some cases, longitudinal steel rods are much more prone to buckling and the concrete effective area is reduced (Figure 6), affecting its strength. The deformation capacity of the RC members can also be seriously affected by the transverse steel reinforcement degradation, since, in the absence of adequate confinement of the concrete core, deformation capacity (curvature ductility) of transverse sections that make it up can vary significantly from what was originally considered in the design.

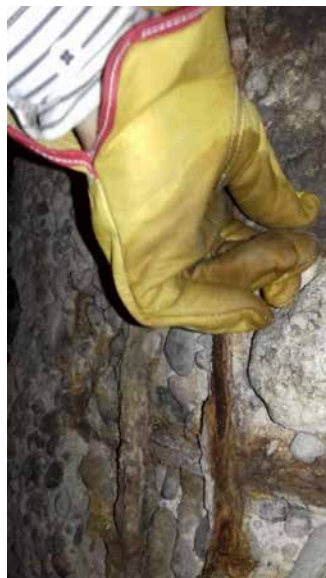
a)

Figure 7. a). Severe corrosion with total loss of main steel reinforcement and b). Light corrosion of concrete slab reinforcement

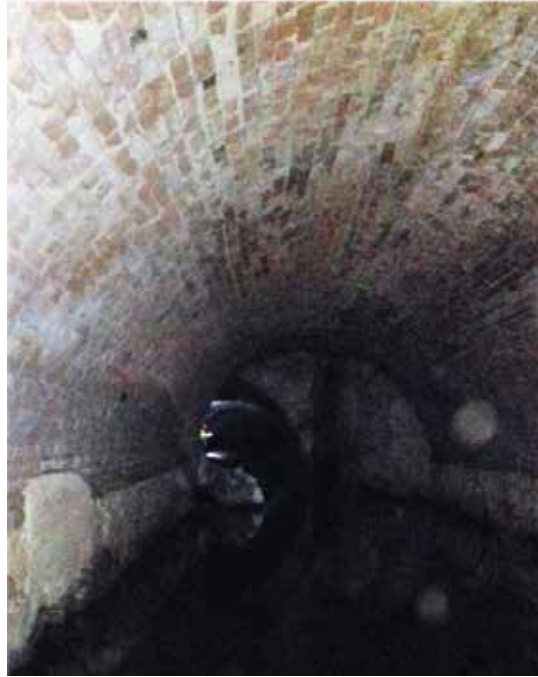
Materials such as brick and stone, joined using mortar, show slight deterioration mainly due to environmental exposure, humidity and internal temperature. The structure built with these materials was observed to be stable and some areas were detected to have stains, eroded areas, soft areas or flabby areas due to excess of humidity in bricks, with efflorescence in the form of crystallized salts (Figure 8). Stains were also visualized by the

Figure 8. Brick underground culverts-arch's general view with efflorescence presence (Mundo, 2019)

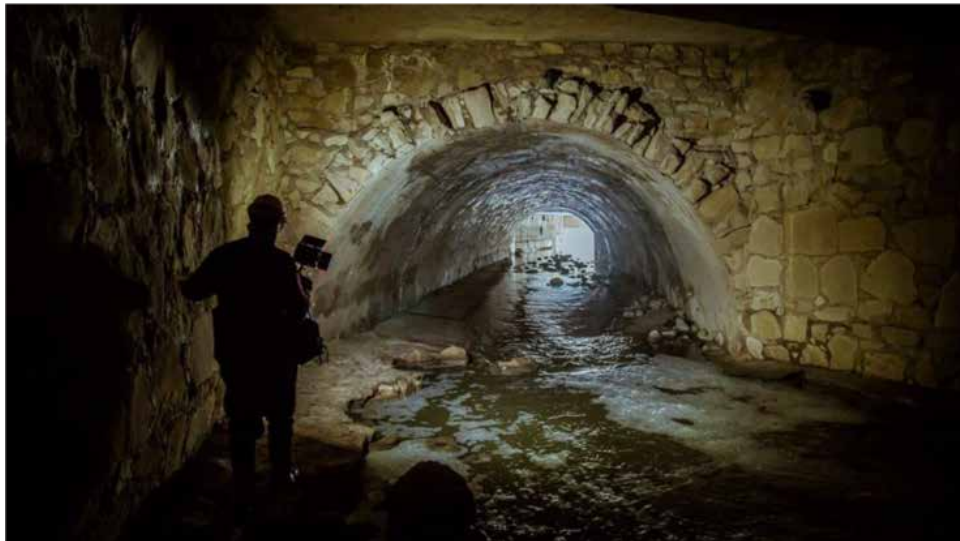
chemical reaction with water and by bacteria or fungi, including mosses on stones as a result of biological degradation (Figure 9).

Figure 9. General view section of the stone underground culverts-arch's (Tavera, 2018)

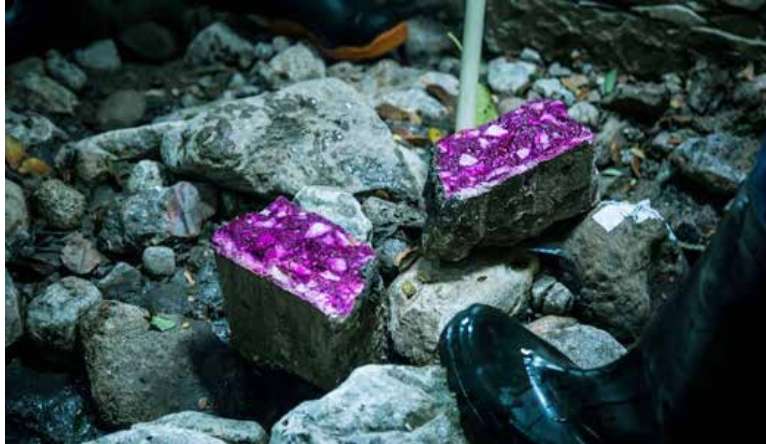
Figure 11. In-situ carbonation front measurement in a concrete sample of the slab, using an acid-base indicator solution: phenolphthalein (Tavera, 2018)

all material. From data obtained through the concrete's phenolphthalein test, an advanced depth of carbonate front was found (2 cm), this value, even in certain degraded parts, is greater than the coating's free zone. Concrete's pathology, together with alkalinity loss, promotes the appearance of damage such as fine cracks and flabby areas, which end up in delamination near the reinforcement steel level with light, medium, strong and severe category (Carmona, 2003). This was corroborated by material detachment over 25% of the slab and beams surface analyzed *in situ*. Another consequence is the generalized reinforcing steel's depassivation, forming electrochemical cells due to chloride diffusion and sulfate ions, which increase their mobility in carbonated concrete. Sewage aggressive agents and its vapors, as well as the atmosphere of the drainage system, in addition to the alkaline reserve leaching, are the accelerating factors that keep the structure in constant degradation.

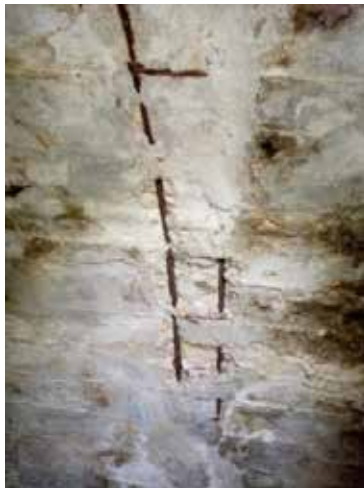
Generally, steel reinforcement embedded in concrete is protected from corrosion due to two protection characteristics: a concrete cover thickness as a physical barrier and the iron oxide layer (of the order of a couple of nanometers) that forms on its surface, due to high alkalinity of the surrounding concrete, with values higher than 12.6 pH (Peguin *et al.*, 1972). This phenomenon is known as passivation (Fontana, 1986) and prevents steel reinforcement corrosion from spreading further. However, the structure, when acting in its environment, begins to degrade due to various mechanisms that are a function of corrosive elements aggressiveness in the internal environment, soil and water, in which they are in permanent contact (Figure 12).

Figure 12. Underground culverts-arch's internal lining with strong steel corrosion problems and crystallized salts from concrete leaching (Mundo, 2019)

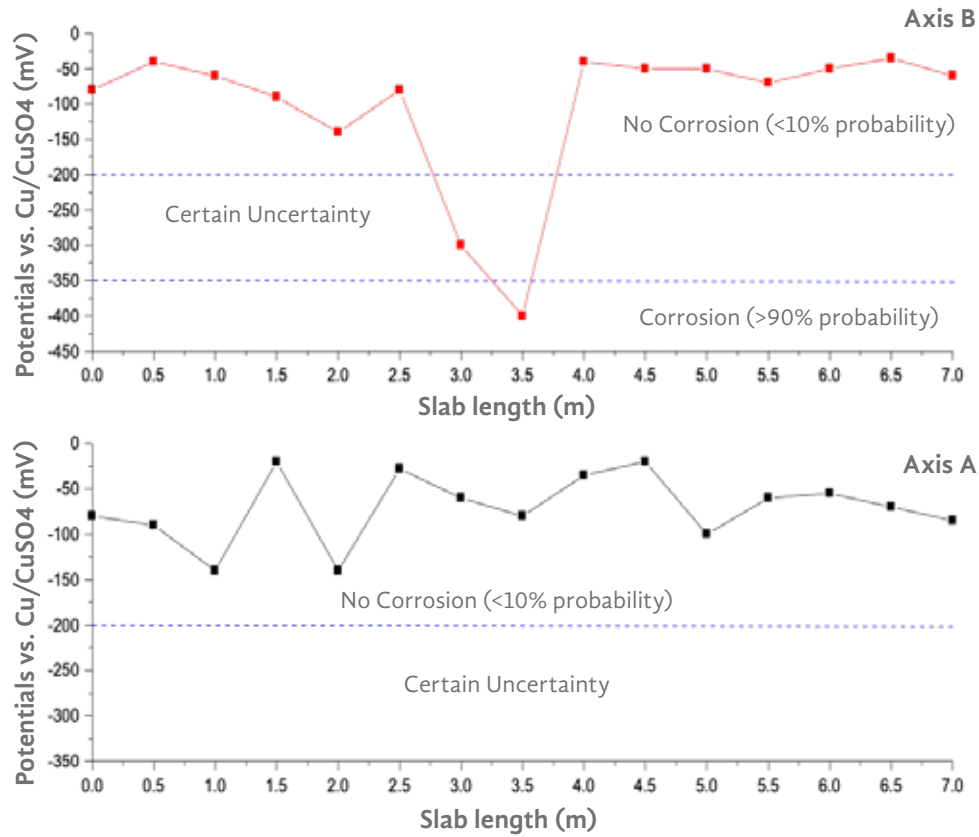
Corrosion potential measurements carried out on the slab and beam that make up the superstructure of the section under evaluation reveal that reinforcement is in active condition. The graph in Figure 13, axis B, corresponding to the slab, shows corrosion potential values that vary from -35 mV to -140 mV, with values ranging from -300 mV to -400 mV detected at the center of the axis. The graph in Figure 13, axis A, of the slab, showed potential values between -20 mV and -140 mV. These values, according to Table 1, indicate that for non-visible reinforcing steel, in general, there is a 10% probability of corrosion for both axes. It should be noted that the most critical values observed in Figure 13 for axes A and B were in the range of some uncertainty and 90% probability of corrosion according to the ASTM C876-91 standard. Therefore, it can be pointed out that the area with high structural problem, where the most negative potentials were computed, is at the center of slab, at 300 cm and 350 cm from its total length. These values coincide with the visible damage observed in the area showing segregations with openings of 10 cm and depths of 1 to 5 cm on average, with corroded exposed steel (Figure 14a).

Figure 13. Corrosion potentials (E_{corr}) in reinforced concrete slab

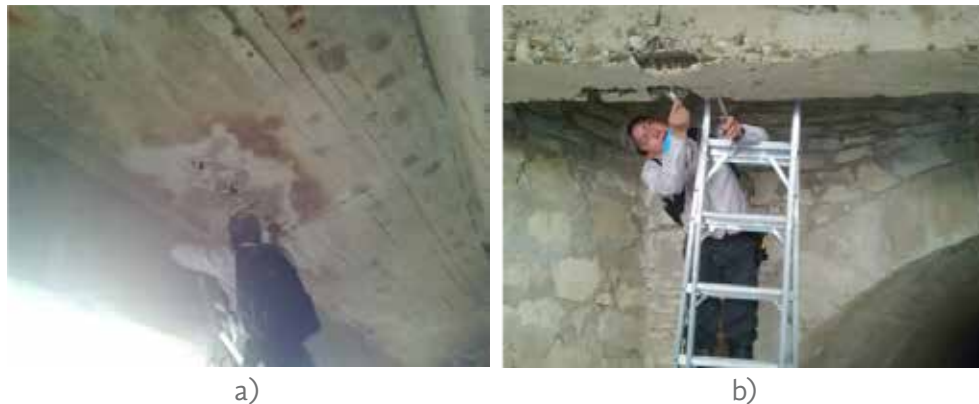
Figure 14. a). Measurement of deterioration (segregations) in slab and b). Measurement of beam's segregations with digital vernier "Mitutoyo" and transparent millimetric ruler

should be noted that the most negative potentials were in the range of some uncertainty according to the standard. Therefore, it can be pointed out that the higher structural problem, which presents the most negative potentials, is located at 450 and 600 cm from its total length. These values match with the visible damage observed in the beam area, which shows segregations with openings of 15 cm and depths of 2.3 to 5 cm, with exposed corroded steel (Figure 14b).

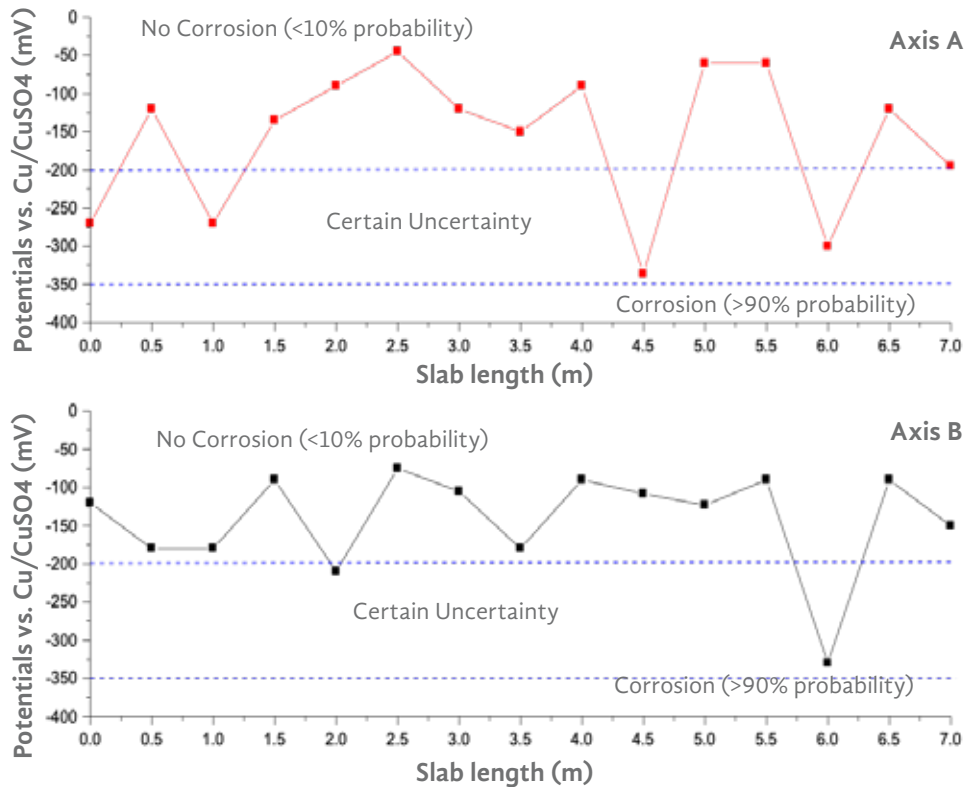
From the A axis of Figure 15, corresponding to the beam, potential values that vary from -45 mV to -336 mV were observed. In graphic 15, in axis B of the beam, values between -75 mV and -330 mV were observed. These values, according to Table 1, indicate for non-visible steel reinforcement have a 10% risk of corrosion damage and some uncertainty for both axes. It

Figure 15. Corrosion potentials (E_{corr}) in reinforced concrete beam
