CORROSION AND STRUCTURAL
INSPECTION OF AN INTERNAL
REINFORCED CONCRETE ELEMENT
LOCATED AT CHAINAGE 0+145 IN
THE SAN ROQUE UNDERGROUND
CULVERTS-ARCH, IN TUXTLA
GUTIERREZ, CHIAPAS

Therefore, this paper presents the analysis of visual inspection and specific chemical carbonation tests, as well as electrochemical measurements of corrosion potentials (ASTM C876-91) performed on an internal reinforced concrete element, which crosses the San Roque underground culverts-arch at chainage 0+145. This investigation was derived from two incursions inside the San Roque underground culverts-arch by a group of specialists in materials science, structures, hydraulics, hydrology, topography and social communication (see the following link on youtube: https://www.youtube.com/watch?v=MkXuOTc_VkI). The main results associated with materials science (corrosion) and structures are presented in this paper.

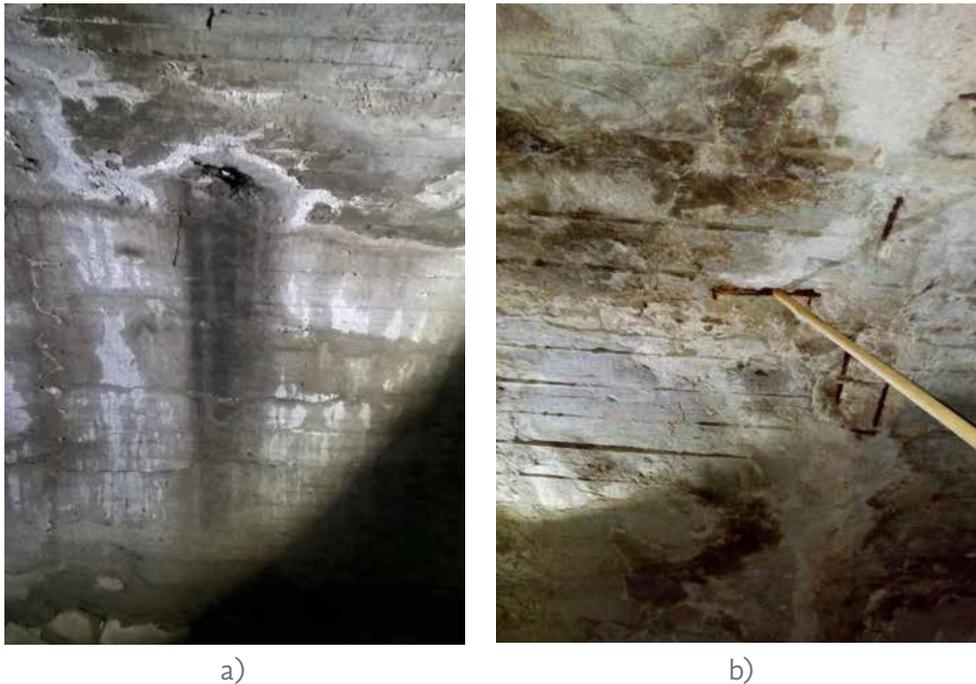
The infiltration through cracks, crevices and voids in the underground culverts-arch internal protection (reinforced concrete lining) were observed, causing staining, efflorescence and leaching of calcium hydroxide and other components, which are dispersed over the sides of the concrete surface (Figure 3a). The steel reinforcement of the concrete, both longitudinal and transversal, shows visible corrosion, clearly exposed, with detachment of materials typical of the lining zone and crystallized alkaline leachates, as can be seen on the chainage 0+568 (Figure 3b).

Figure 3. Material degradation of the "San Roque underground culverts-arch" structure (Mundo, 2019)

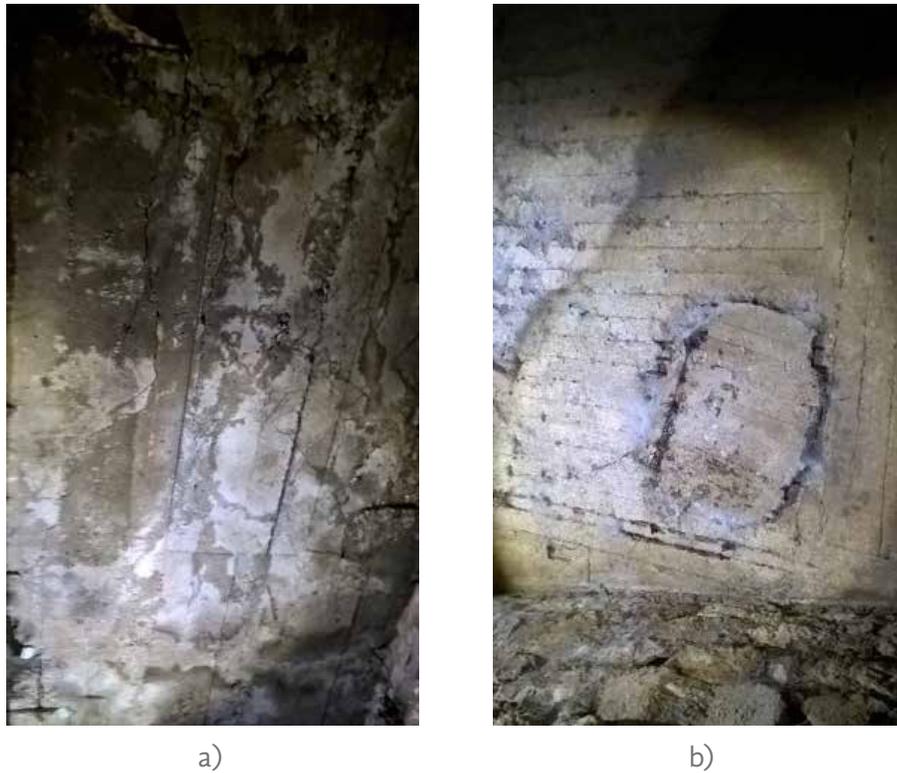
In the reinforced concrete (RC) system, beams and slabs, located at the chainage 0+145, various undesirable structural aspects were observed, such as: a) exposure of longitudinal and transverse steel reinforcement, b) partial longitudinal cracking (Figures 4a) and bursting shown in Figure 4b, highlighted in a blue box. It was observed that, in this last damage zone located in the slab structure, maintenance work had already been carried out (unknown dates of execution). However, it was noted that the construction process used in such maintenance is of low quality, as shown in Figure 4b. Lack of adequate maintenance is evident and therefore, there are notorious material failures such as cracking and detachments in several sections of the RC slab.

Figure 4. Material failures: (a). Cracking and (b). Slab bursting

The concrete patch observed in Figure 4b (blue square) corresponds to blowout damage, generally caused by reactive aggregates and cement that are high in alkalis, or in its case, by aggregates that expands when is in constant contact with water or humidity. In this case, it is a severe burst that has been repaired, since the damage diameter is greater than 5 cm and depth greater than 2.5 cm (Carmona, 2003).

Cracks located on the analyzed slab lower surface, in chainage 0+145, are structural damage caused by dead and live loads, ranging from strong to severe cracking, with cracks from 0.6 mm and larger than 1 mm wide.

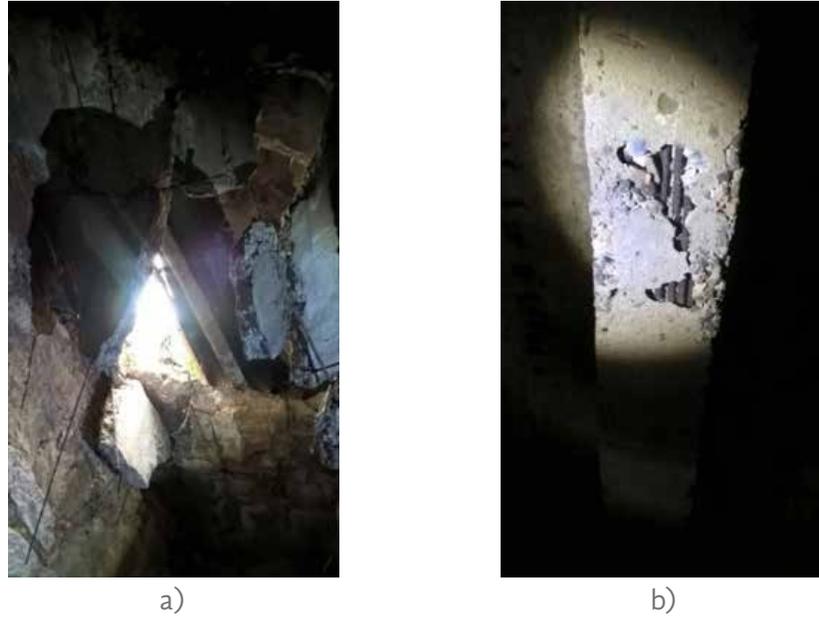
A relevant aspect of the inspection was the identification of a collapsed area of the reinforced concrete structure, located at chainage 0+145, as shown in Figure 5a. In this collapsed section, the severe deterioration due to corrosion of the steel reinforcement and the concrete degradation can be observed. In addition, problems were observed in reinforced concrete beams that have never received maintenance, presenting areas without concrete cover on the bottom side of the element, exposing the steel reinforcement and, therefore, with an active process of generalized corrosion. Moreover, concrete segregation was observed in beams, because the material used as coarse aggregate in the construction process is either from boulder or from river (Figure 5b).

Figure 5. a). Slab collapse and b). Areas without concrete cover and with visible concrete segregation in beams of the RC structure

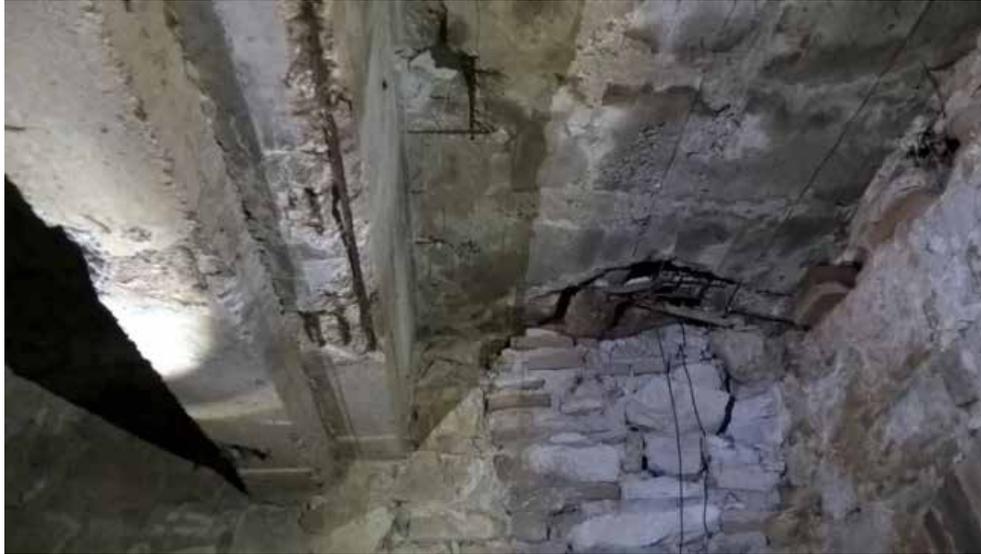
In general, this section of the structure has no conservation and a serious material deterioration process. Various pathologies were observed, both in longitudinal beams, as well as in the reinforced concrete slab (Figure 6), where there are problems of spalling, delamination, segregation, bursting, efflorescence, filtration, humidity, leaching, little or complete lack of the concrete covering for the steel reinforcement and, with light to severe electrochemical corrosion. The latter, is a phenomenon that is due to the action of electrochemical batteries, where metal (steel reinforcement) suffers dissolution in anodic regions, without attacking the cathodic regions, not affecting equally all the metallic surface that are in contact with electrolytic conductivity systems, where the presence of water molecules on the material surface is necessary for this deterioration to occur (Otero, 2001), producing in visible anodic areas, partial or total loss of the bottom longitudinal steel reinforcement (Figure 6, 7a and 7b). In this area, the use of inadequate construction process techniques, lack of quality control of materials and little or no supervision provided is also visible.

Figure 6. General view of slabs and beams with various pathologies

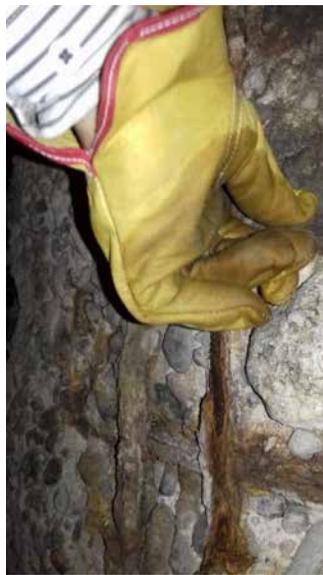
a)

Figure 7. a). Severe corrosion with total loss of main steel reinforcement and b). Light corrosion of concrete slab reinforcement

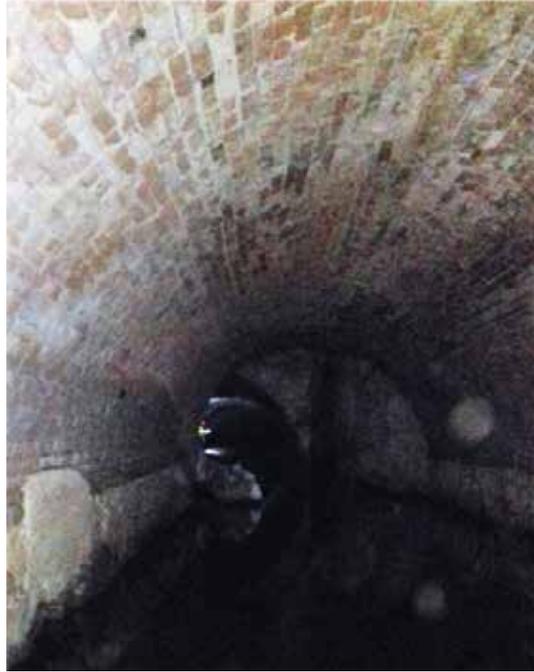
Materials such as brick and stone, joined using mortar, show slight deterioration mainly due to environmental exposure, humidity and internal temperature. The structure built with these materials was observed to be stable and some areas were detected to have stains, eroded areas, soft areas or flabby areas due to excess of humidity in bricks, with efflorescence in the form of crystallized salts (Figure 8). Stains were also visualized by the

Figure 8. Brick underground culverts-arch's general view with efflorescence presence (Mundo, 2019)

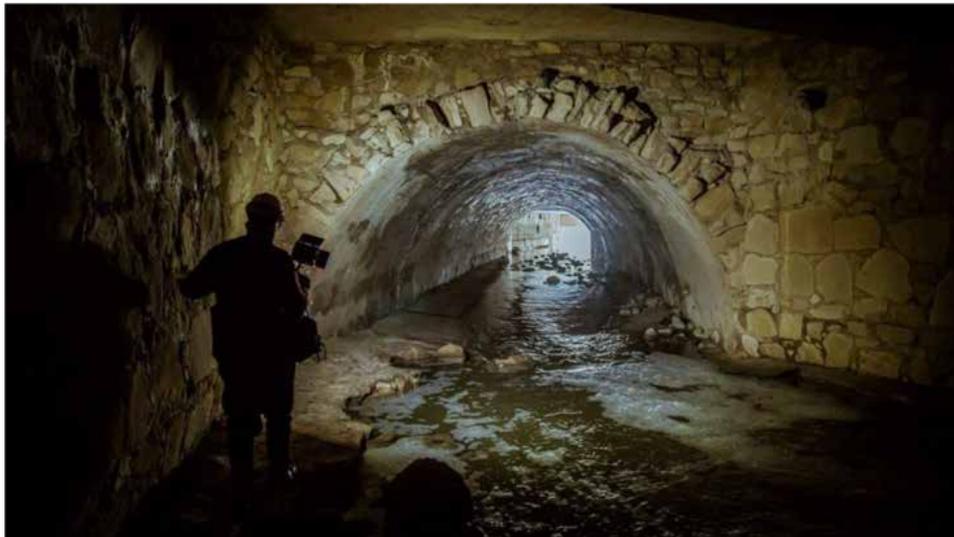
chemical reaction with water and by bacteria or fungi, including mosses on stones as a result of biological degradation (Figure 9).

Figure 9. General view section of the stone underground culverts-arch's (Tavera, 2018)

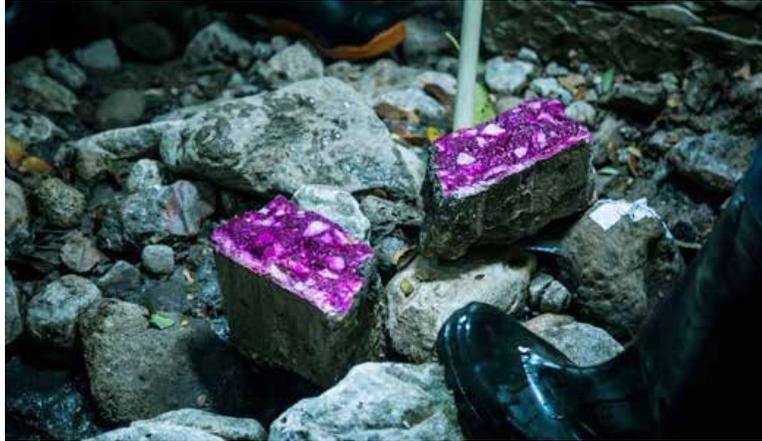
Figure 11. In-situ carbonation front measurement in a concrete sample of the slab, using an acid-base indicator solution: phenolphthalein (Tavera, 2018)

all material. From data obtained through the concrete's phenolphthalein test, an advanced depth of carbonate front was found (2 cm), this value, even in certain degraded parts, is greater than the coating's free zone. Concrete's pathology, together with alkalinity loss, promotes the appearance of damage such as fine cracks and flabby areas, which end up in delamination near the reinforcement steel level with light, medium, strong and severe category (Carmona, 2003). This was corroborated by material detachment over 25% of the slab and beams surface analyzed *in situ*. Another consequence is the generalized reinforcing steel's depassivation, forming electrochemical cells due to chloride diffusion and sulfate ions, which increase their mobility in carbonated concrete. Sewage aggressive agents and its vapors, as well as the atmosphere of the drainage system, in addition to the alkaline reserve leaching, are the accelerating factors that keep the structure in constant degradation.

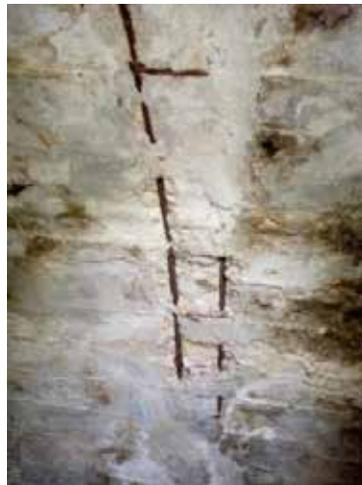
Generally, steel reinforcement embedded in concrete is protected from corrosion due to two protection characteristics: a concrete cover thickness as a physical barrier and the iron oxide layer (of the order of a couple of nanometers) that forms on its surface, due to high alkalinity of the surrounding concrete, with values higher than 12.6 pH (Peguin *et al.*, 1972). This phenomenon is known as passivation (Fontana, 1986) and prevents steel reinforcement corrosion from spreading further. However, the structure, when acting in its environment, begins to degrade due to various mechanisms that are a function of corrosive elements aggressiveness in the internal environment, soil and water, in which they are in permanent contact (Figure 12).

Figure 12. Underground culverts-arch's internal lining with strong steel corrosion problems and crystallized salts from concrete leaching (Mundo, 2019)

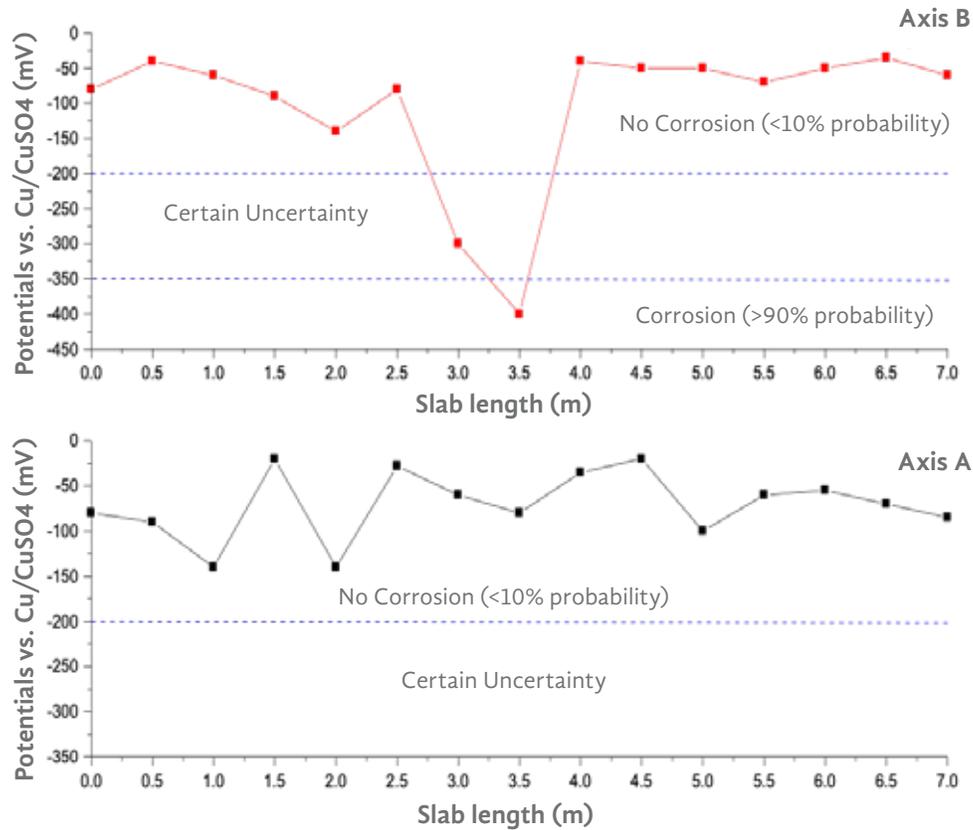
Corrosion potential measurements carried out on the slab and beam that make up the superstructure of the section under evaluation reveal that reinforcement is in active condition. The graph in Figure 13, axis B, corresponding to the slab, shows corrosion potential values that vary from -35 mV to -140 mV, with values ranging from -300 mV to -400 mV detected at the center of the axis. The graph in Figure 13, axis A, of the slab, showed potential values between -20 mV and -140 mV. These values, according to Table 1, indicate that for non-visible reinforcing steel, in general, there is a 10% probability of corrosion for both axes. It should be noted that the most critical values observed in Figure 13 for axes A and B were in the range of some uncertainty and 90% probability of corrosion according to the ASTM C876-91 standard. Therefore, it can be pointed out that the area with high structural problem, where the most negative potentials were computed, is at the center of slab, at 300 cm and 350 cm from its total length. These values coincide with the visible damage observed in the area showing segregations with openings of 10 cm and depths of 1 to 5 cm on average, with corroded exposed steel (Figure 14a).

Figure 13. Corrosion potentials (E_{corr}) in reinforced concrete slab

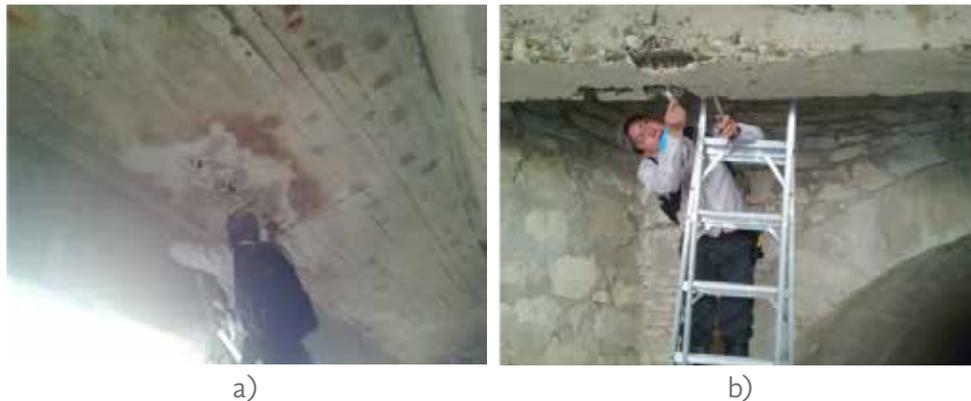
Figure 14. a). Measurement of deterioration (segregations) in slab and b). Measurement of beam's segregations with digital vernier "Mitutoyo" and transparent millimetric ruler

should be noted that the most negative potentials were in the range of some uncertainty according to the standard. Therefore, it can be pointed out that the higher structural problem, which presents the most negative potentials, is located at 450 and 600 cm from its total length. These values match with the visible damage observed in the beam area, which shows segregations with openings of 15 cm and depths of 2.3 to 5 cm, with exposed corroded steel (Figure 14b).

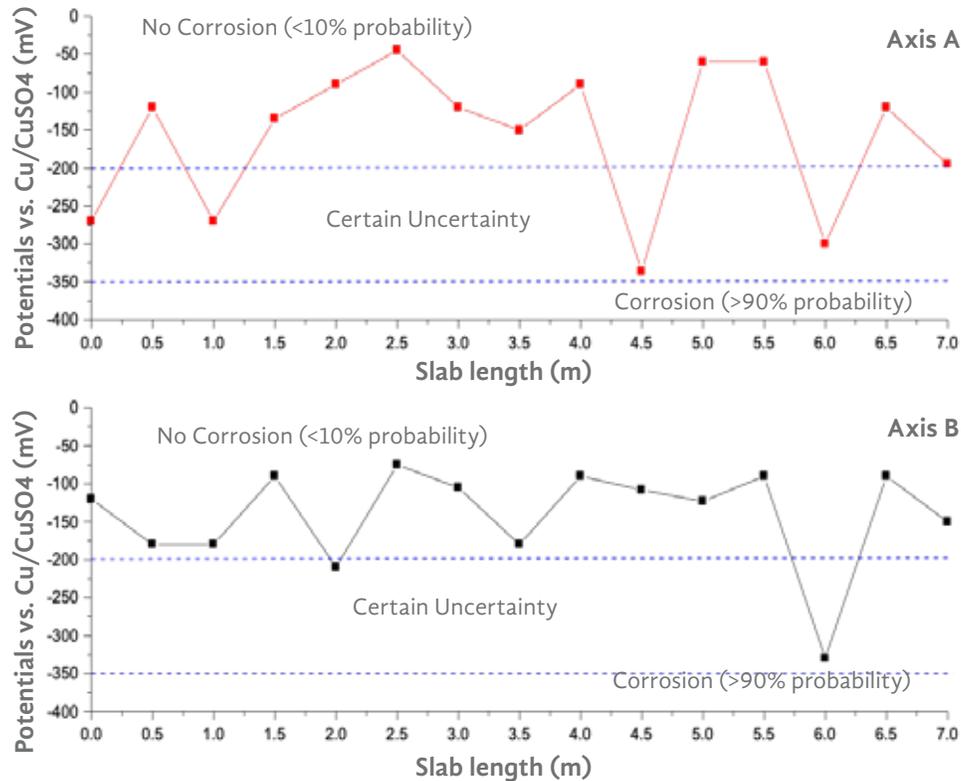
From the A axis of Figure 15, corresponding to the beam, potential values that vary from -45 mV to -336 mV were observed. In graphic 15, in axis B of the beam, values between -75 mV and -330 mV were observed. These values, according to Table 1, indicate for non-visible steel reinforcement have a 10% risk of corrosion damage and some uncertainty for both axes. It

Figure 15. Corrosion potentials (E_{corr}) in reinforced concrete beam
