STRUCTURAL STRENGTHENING OF A TRADITIONAL ADOBE HOUSE IN CHIAPA DE CORZO, CHIAPAS

Lorenzo Franco Escamirosa Montalvo¹
María de Lourdes Ocampo García¹ and
Roberto Arroyo Matus²

¹Autonomous University of Chiapas, ²Autonomous University of Guerrero

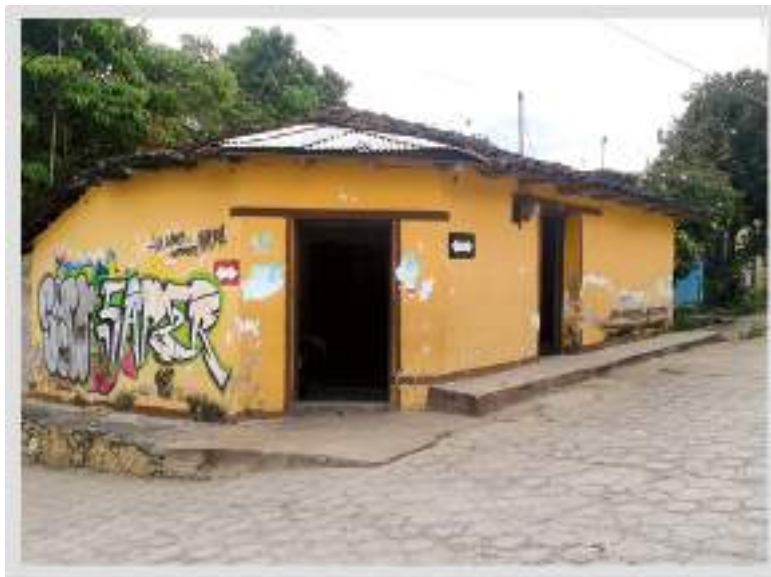
In this paper reference is made to one of the selected households, owned by Evangelina Aguilar Montero who noted that the property is more than 80 years old. The property is located in seismic zone 1, between Avenida Miguel Hidalgo and Calle Tomas Cuesta, in the San Vicente neighborhood, with geographic coordinates UTM (498673.62, 1847525.79) and an elevation of 433.78 meters above sea level. Its structure is formed by a stone masonry foundation, 40 cm. thick adobe walls, clay tiled roof supported with a structure of round wooden beams and planks. In the visual structural assessment, serious cracks in the walls and cracks in the corners we observed, which adversely affect the stiffness and cause an increase of the vibration period of the house (Figure 1).

Figure 1. Traditional adobe home owned by Evangelina Aguilar Montero

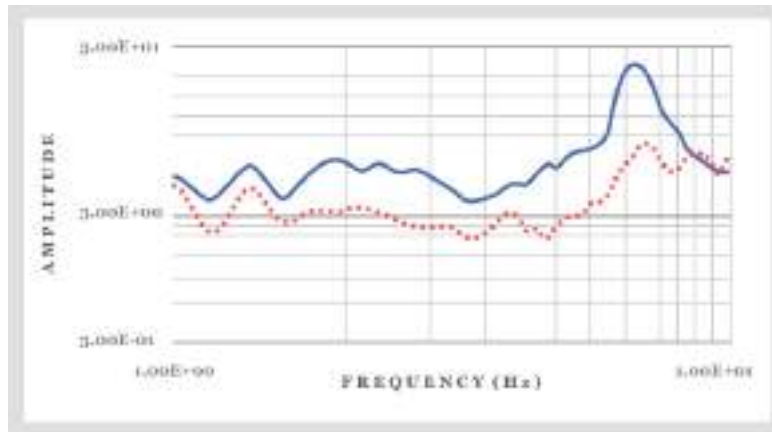
Subsequently the accelerometer was installed in the house to obtain the necessary measurements to determine the fundamental periods of vibration in the house and in the corresponding soil. According to seismograph records stored in 3 orthogonal dimensions of 30 seconds duration each, and based on the calculations of the Fourier spectra in each record, the transfer function, or spectral ratio was established using the Nakamura technique. The results indicate that the fundamental vibration period on average is high: (. Escamirosa, et al, 2013) at 0.2133 seconds in the soil to 0.1506 seconds for the house(Figures 2 and 3).

Figure 3. Fundamental period of the house with a vibration of 6.64 Hz that are equal to 0.1506 seconds

According to measurements taken before the structural reinforcement, the adobe house owned by Evangelina Montero had a fundamental period of vibration of the order of 0.1506 seconds, above the range of 0.08 to 0.12 second which is considered structurally sound by Hernandez, et al. (1979). Therefore, it was established that the structure of the house had high seismic vulnerability and therefore a safety risk for its inhabitants.

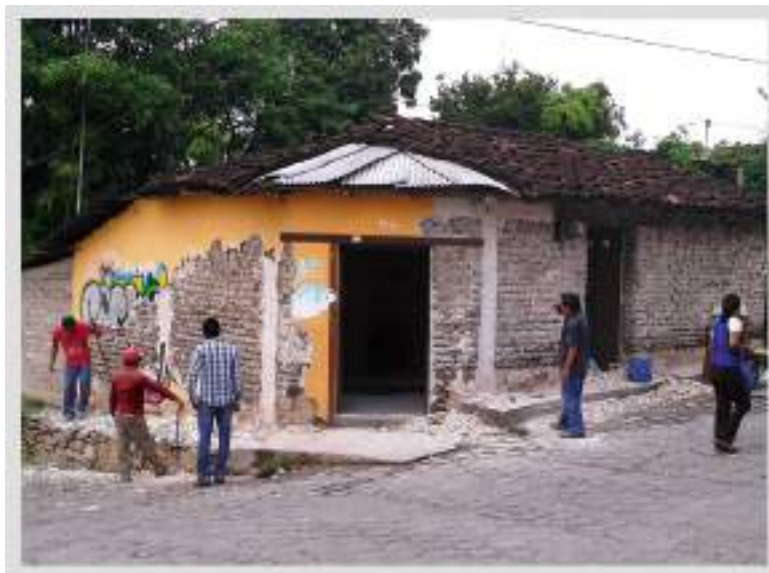
Figura 4. Removal of the existing mortar on the house

1. Removal of doors: Frames and panels of 3 wooden doors were removed carefully to avoid unnecessary damage to the adobe walls.
2. Removal of mortar: On both sides of the existing walls the coating was removed, essentially made of lime-sand (Figure 4).

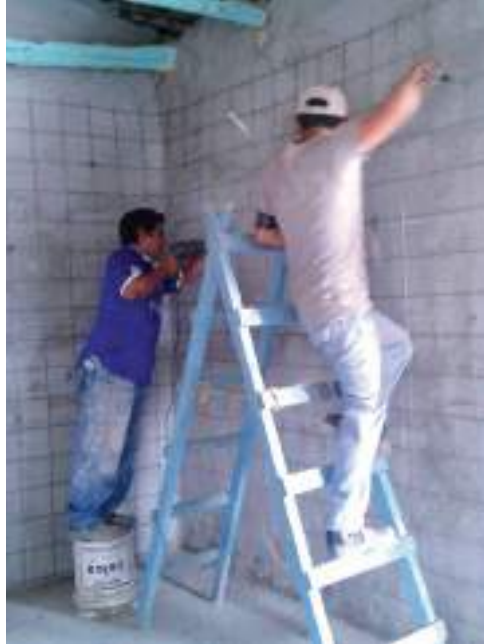
Figure 5. Attaching the wire mesh 6x6 / 10x10 inside the housing

3. Cleaning and wetting of walls: before applying new mortar work.
4. Application of the first layer of mortar: cement-sand mortar was used with 1: 3 to cover the walls, throwing mortar by hand and then, with a wooden trowel spread to a minimum thickness of 1 cm . The mortar was applied according to the original shape of the wall; that is, no vertical leveling was considered for the walls.
5. Placing of steel mesh: On the walls welded steel mesh (6x6 / 10x10) was placed and on both sides were simultaneously anchored with wire anchors and annealed wire. The anchoring was previously carried out by drilling with a 5/16 “drill bit; the wire was placed forming a grid of

1.35 m. and annealed wire at a smaller lattice of 45 cm. Overlaps of mesh sections were performed at 60 cm. (Figure 5).

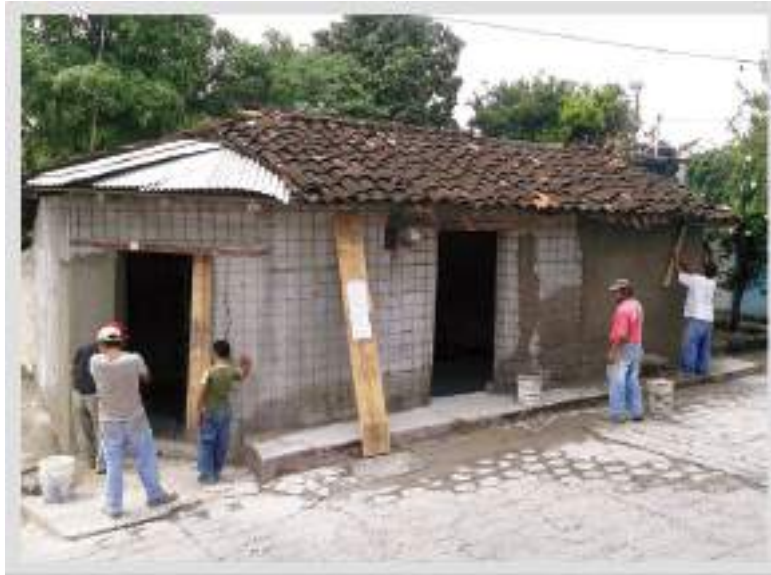
Figure 6. Application of the second coat of cement-sand mortar

6. Application of the second layer of mortar: The second layer of cement-sand mortar requires wet walls in order to obtain optimum concrete strength. Like the previous layer, the minimum thickness was 1 cm. (Figure 6).
7. Finished walls: a thin layer of putty produced from cement-lime with a 1:10 proportion was used for the final finish on internal and external walls, like the original caulking on adobe houses (Figure 7).
8. Placement of doors: 3 doors were hung and properly adjusted.
9. Replacement of damaged wood: The wood planks that support the clay tiles were replaced by 1 “x4” pine planks.

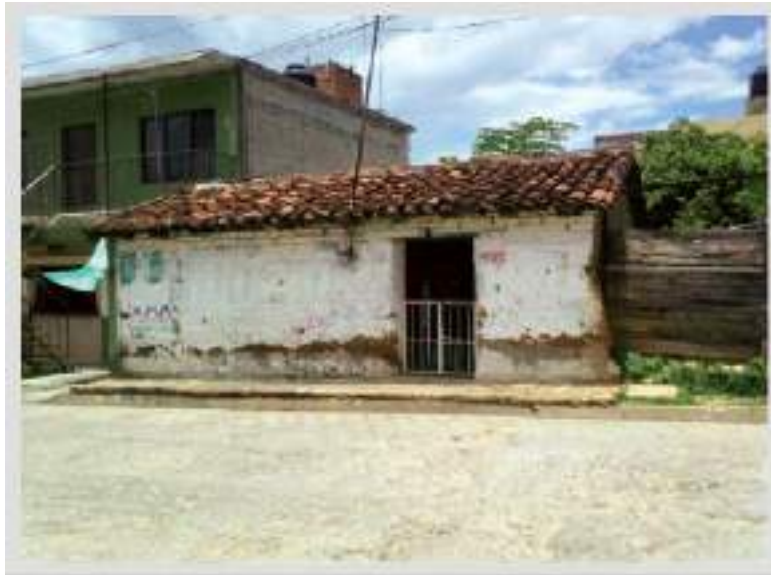
Figure 8. Traditional adobe home of Reyneria Moreno Cuesta

As in the previous case, the conditions of the structural elements in the home were analyzed and it was observed that due to a lack of coating on the walls, the adobe had been exposed to climatic variations over many years, which has resulted in adobe in very poor condition. There were also serious structural problems found in the walls, cracks were observed, inclination (unplumbed)

and cracks in the head walls with interceptions in the main and rear facades. In the roof structure, two rotten round wooden beams were identified, and some planks supporting the tiles and the wooden lintel of the door located in the rear façade showed termite damage.

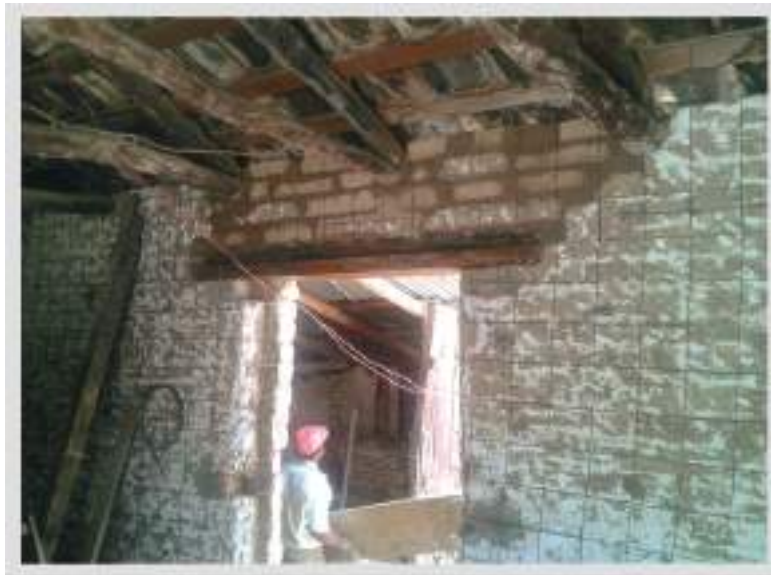
Figure 9. Strengthening the existing lintel with a pine wooden plank.

1. Removal of the existing layer of lime.
2. Strengthening the wooden lintel: At the door of the rear facade, an 8 cm. thick wooden pine plank was placed in the bottom of the existing lintel (Figure 9).

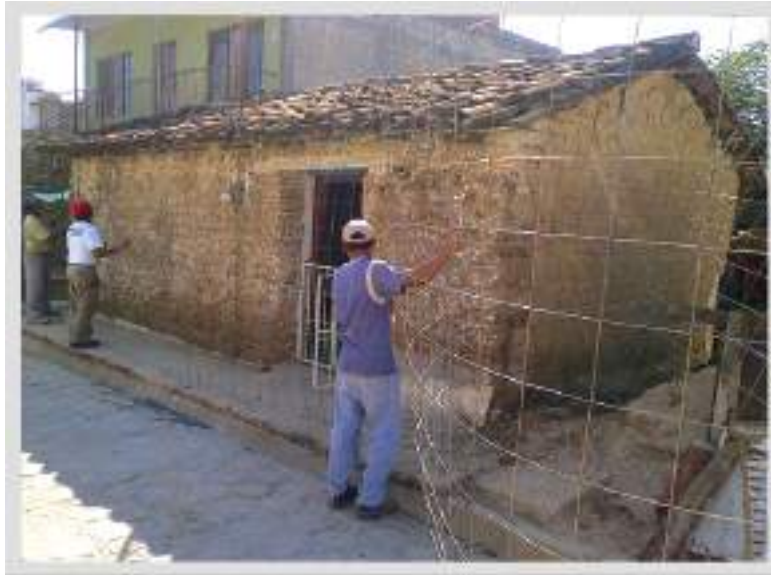
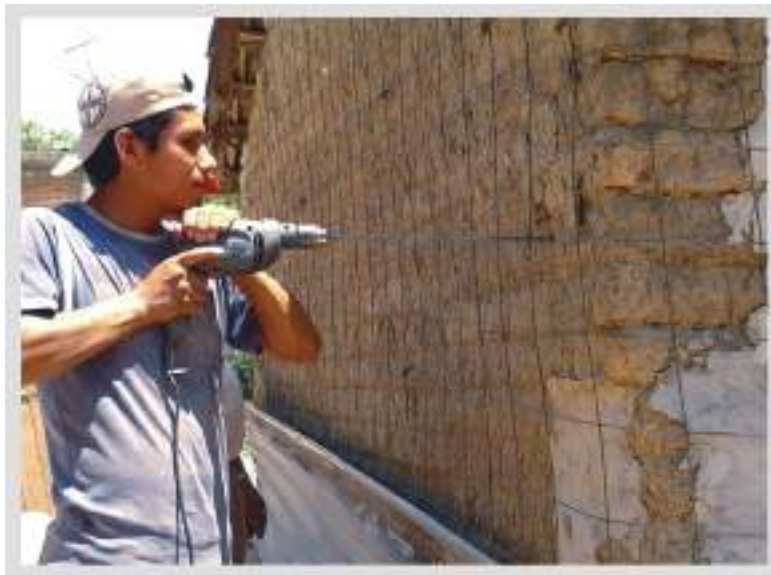
Figure 10. Attaching the wire mesh

Figure 11. Drilling the adobe to fix the steel mesh

3. Placement of steel mesh (Figures 10 y 11).
4. Removal of the metal doors.
5. Cleaning and wetting the walls.

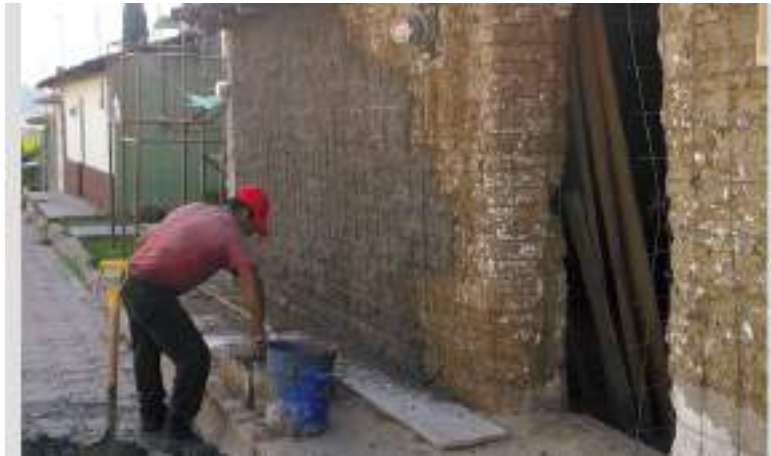
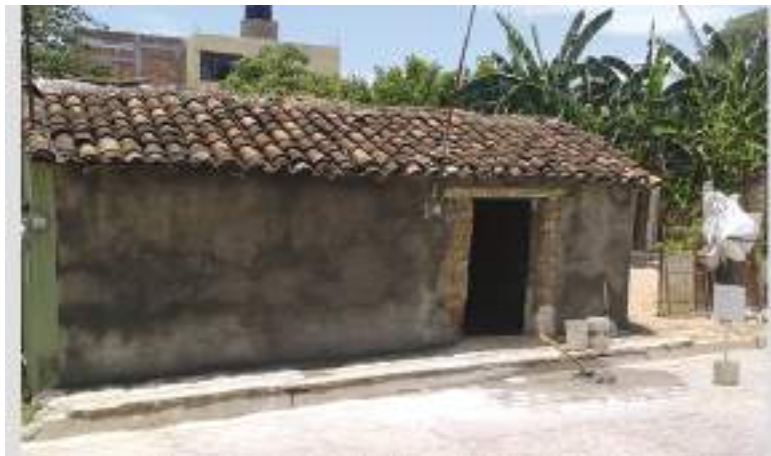
Figura 12. Application of cement-sand mortar

Figure 13. Application of the cement-sand mortar

6. Application of mortar: the first layer of cement-sand mortar was placed, ensuring a minimum thickness of 1 cm; After a long enough time for the mortar to set (2

hrs.), the second layer of a minimum thickness of 1 cm was applied., which was smoothed with wooden trowel. Similarly as in the previous housing, troweling was performed according to the level of the vertical walls (Figure 12 and 13)
