SEISMIC VULNERABILITY  
ASSESSMENT OF TWO RURAL  
HOUSING PROTOTYPES BUILT WITH  
CONCRETE HOLLOW BLOCKS, IN  
OCUILAPA DE JUÁREZ, CHIAPAS

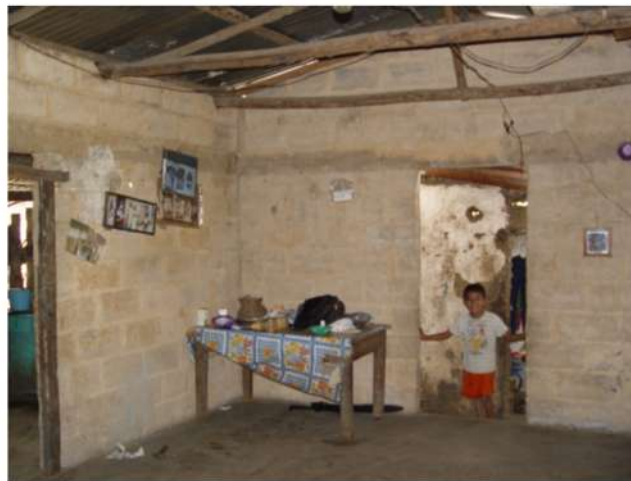
**Image 2.** Inside of a hollow block house

On the other hand, in homes built with annealed mud walls, solid blocks or concrete hollows with two cells, it was observed that their state of conservation is greater; nevertheless, the structure does not guarantee security for its occupants due to the following conditions: Of the total of the houses, 62% have masonry foundations with local stone and the rest of reinforced concrete. In both cases the elements are suitable for the type of rocky soil in the area; however, 79.42% of the houses are built with hollow concrete block walls with two cells and of these, 30.55% have cracks as a result of which the walls only have vertical reinforcement steel in the corners and intersections, without considering the spans of doors and windows, and in the horizontal sense, most only have a slab of enclosure at the height of doors and windows. The houses were built with few confining elements in their walls (images 2 and 3), which are insufficient according to current technical standards (NTCM, 2004). In fact, they do not comply with what is specified in the reinforcement section for structural integrity for rural housing and the materials that give rise to the system do not comply with the specifications of said norm.

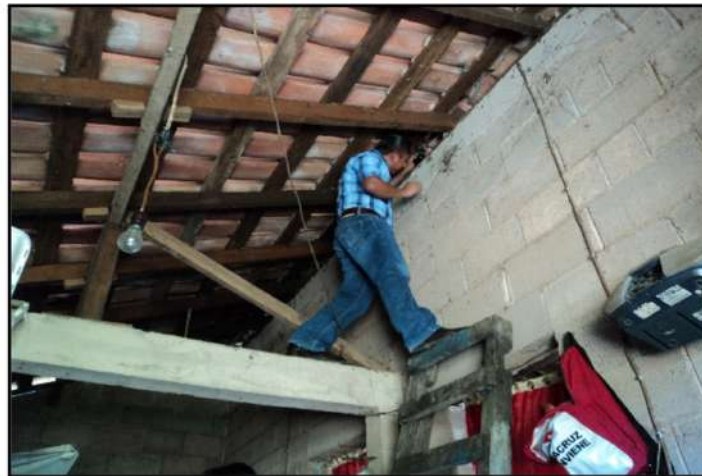
**Image 13.** Placement of the sensor in P3 of V2

Figure 13 shows the placement of the accelerograph in the house V2 at the indicated point P3, which corresponds to the geometric center. The records obtained were in three orthogonal directions of 30 seconds duration and the results obtained in the analysis made, allowed to establish that the periods of fundamental vibration in average per dwelling are the following:

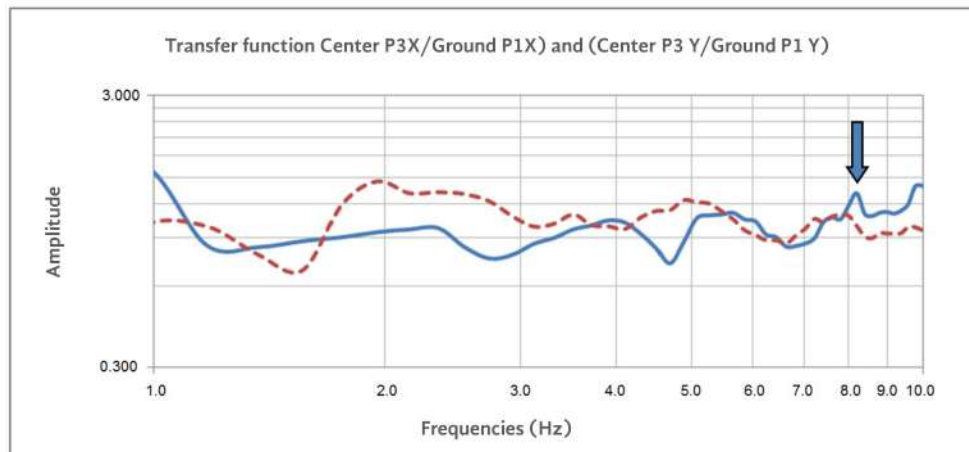
**Image 16.** Transfer function of house V1  
(Continuous line-X, discontinuous-Y)

Next, Images 16 and 17, show the transfer functions in each dwelling; the continuous function corresponds to the short address of the dwelling (x), and the dotted function for the long function (y). These functions were obtained by dividing the Fourier spectra calculated from the accelerometer records in the center of each dwelling (point P3), among the ground ones (point P1). The relationship of both registers allows to establish how the response at point P3 is amplified with respect to point P1. In the images, the frequencies that generate the greatest amplification of the spectral response are highlighted. Right after, the Transfer Function, or spectral ratio, was determined using the Nakamura technique (1989) and the procedure for determining the transfer functions suggested by Lermo and Chávez-García (1994). Finally, the graphs of the transfer functions of houses V1 and V2 indicate the frequencies that, according to the technique applied, respectively represent the fundamental vibration frequencies for said dwellings, of 7.81 Hz (0.128 s) and 9.3 Hz (0.1067 s). It is important to note that according to Lermo (1994), the values of the fundamental period of the structures do not necessarily correspond to the crest of greater amplitude, but depend on the form they take.
