Seismic hazard in the metropolitan area of Tuxtla Gutiérrez: two case studies

— Abstract —

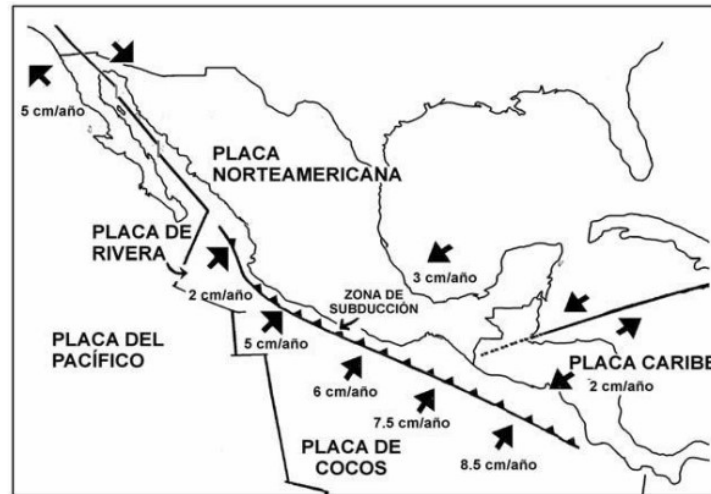
Figure 1. Tectonic plates that interact in the state of Chiapas with their respective movement direction

In Mexico, much of the national territory presents a significant seismic risk, generated mainly by the earthquakes occurring on the Pacific Ocean coast, at the conjunction of the Cocos and North American tectonic plates. Chiapas is a region considerably prone to seismic activity, due to a unique feature in the rest of the Mexican Republic, in which three tectonic plates converge: the Cocos Plate, the North American Plate, and the Caribbean Plate (Figure 1).

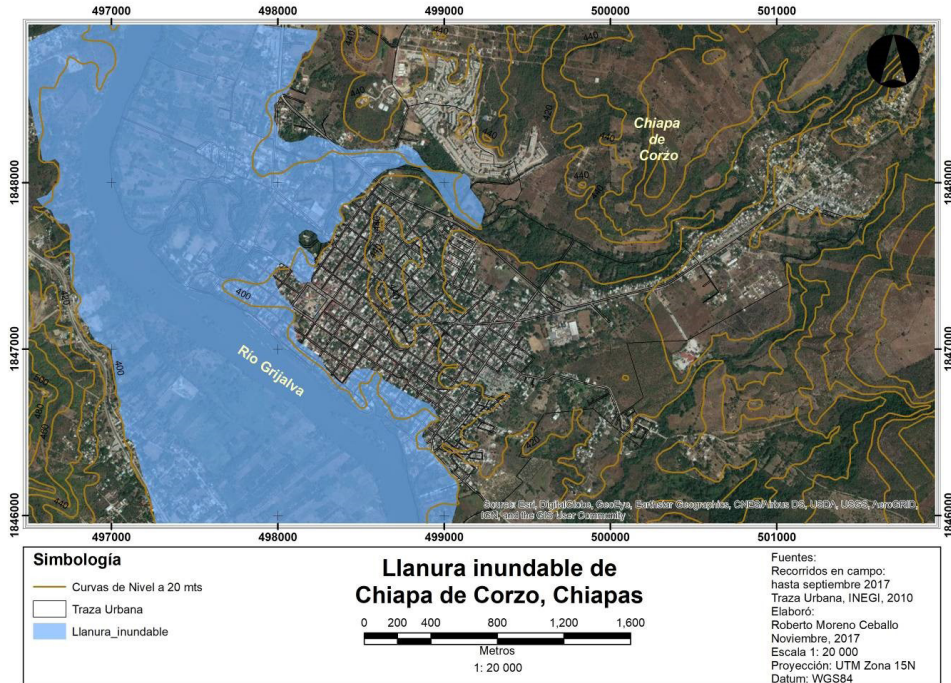
Figure 8. Floodplain of the municipal capital of Chiapa de Corzo

as the incorporation of Civil Protection reports, a map of the Maximum Extraordinary Water Level (NAME) for the municipal capital of Chiapa de Corzo was drawn up (Figure 8).
