SEISMIC VULNERABILITY  
ASSESSMENT OF TWO RURAL  
HOUSING PROTOTYPES BUILT WITH  
CONCRETE HOLLOW BLOCKS, IN  
OCUILAPA DE JUÁREZ, CHIAPAS

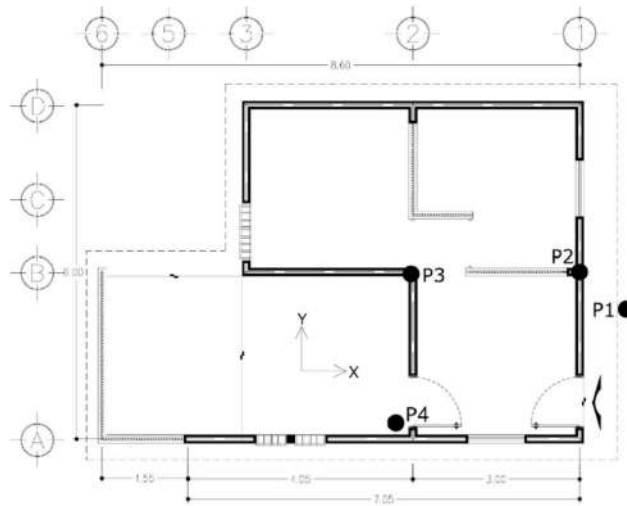
**Image 14.** Location of the house V1 sensor

Images 14 and 15 show the locations of the acceleration sensor in the structure of each dwelling (P2, P3 and P4) and in the free field (P1; floor).

the review of each structural axis of housing V1, and show that, according to the seismic hazard specified by the Civil Works Manual (CFE, 1993) for the study area, the masonry walls have "low vulnerability", so the degree of security of the V1 housing prototype is adequate, and does not require a detailed evaluation for possible structural reinforcement.

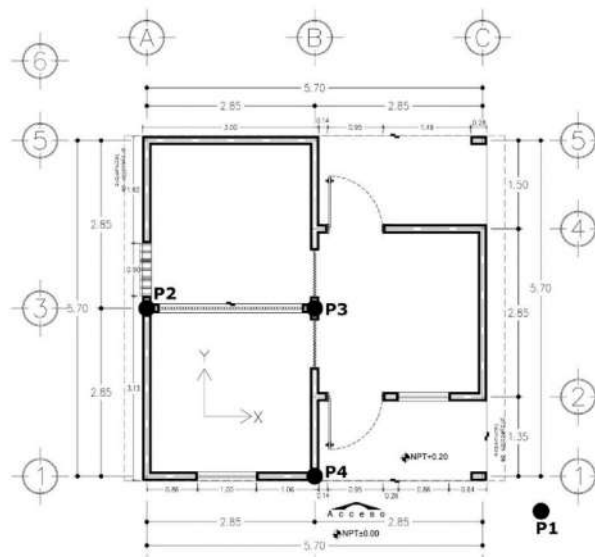
**Image 15.** Location of the house V2 sensor

The results obtained show that the average fundamental period of housing V2, with 0.1067 seconds, is within the recommended range for a dwelling considered structurally healthy, between 0.08 to 0.12 seconds, a parameter established in 1979 by Hernández, *et al.*, and by Arroyo, *et al.*, in 2010; both studies for instrumentation carried out in homes in the state of Guerrero, Mexico. On the other hand, housing V1 with 0.1280 seconds is slightly above that range. It is important to clarify that these values are an indirect generalization of the rigidity of the structural system. Additional elements must be used to be able to affirm if the vulnerability is low or not, especially when the period of construction and soil are similar. However, in this work the periods detected in both houses were taken as parameters indicative of the existence of an adequate walls density in the dwellings.
