CORROSION AND STRUCTURAL
INSPECTION OF AN INTERNAL
REINFORCED CONCRETE ELEMENT
LOCATED AT CHAINAGE 0+145 IN
THE SAN ROQUE UNDERGROUND
CULVERTS-ARCH, IN TUXTLA
GUTIERREZ, CHIAPAS

FACULTY OF ENGINEERING, UNIVERSIDAD AUTÓNOMA DE CHIAPAS, MÉXICO.

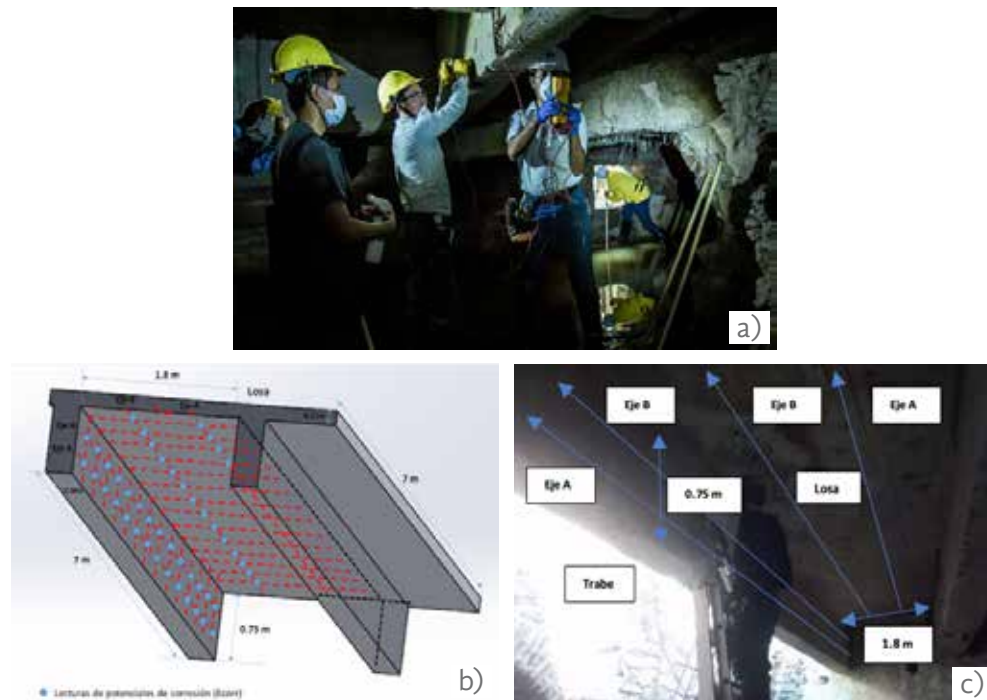
A total of 60 electrochemical readings were taken, one measurement every 50 cm, measured longitudinally on the surface of a 180 cm wide and 700 cm long slab section, as well as on a 75 cm depth and 700 cm long beam (Figure 10b and 10c) with corrosion problems. Measurements of the carbonation front were made on several samples of the collapsed concrete slab, using material remains for the carbonation test, in which an acid-base indicator (phenolphthalein) and a transparent millimetric ruler were used (Figure 11).

Figure 10. a). In-situ measurements of corrosion potentials (Tavera, 2018), b). Detail of the structure's reading points and c). Measurement axes in slab and beam
