CORROSION AND STRUCTURAL
INSPECTION OF AN INTERNAL
REINFORCED CONCRETE ELEMENT
LOCATED AT CHAINAGE 0+145 IN
THE SAN ROQUE UNDERGROUND
CULVERTS-ARCH, IN TUXTLA
GUTIERREZ, CHIAPAS

Therefore, this paper presents the analysis of visual inspection and specific chemical carbonation tests, as well as electrochemical measurements of corrosion potentials (ASTM C876-91) performed on an internal reinforced concrete element, which crosses the San Roque underground culverts-arch at chainage 0+145. This investigation was derived from two incursions inside the San Roque underground culverts-arch by a group of specialists in materials science, structures, hydraulics, hydrology, topography and social communication (see the following link on youtube: https://www.youtube.com/watch?v=MkXuOTc_VkI). The main results associated with materials science (corrosion) and structures are presented in this paper.

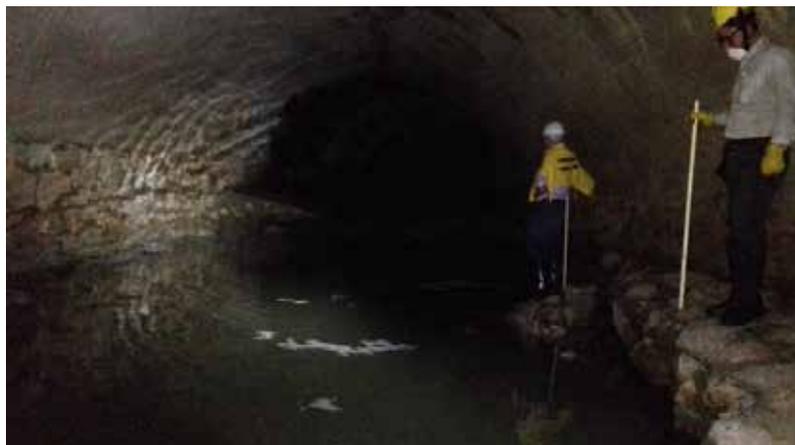
Figure 2. Black water flowing through the "San Roque Underground culverts-arch"

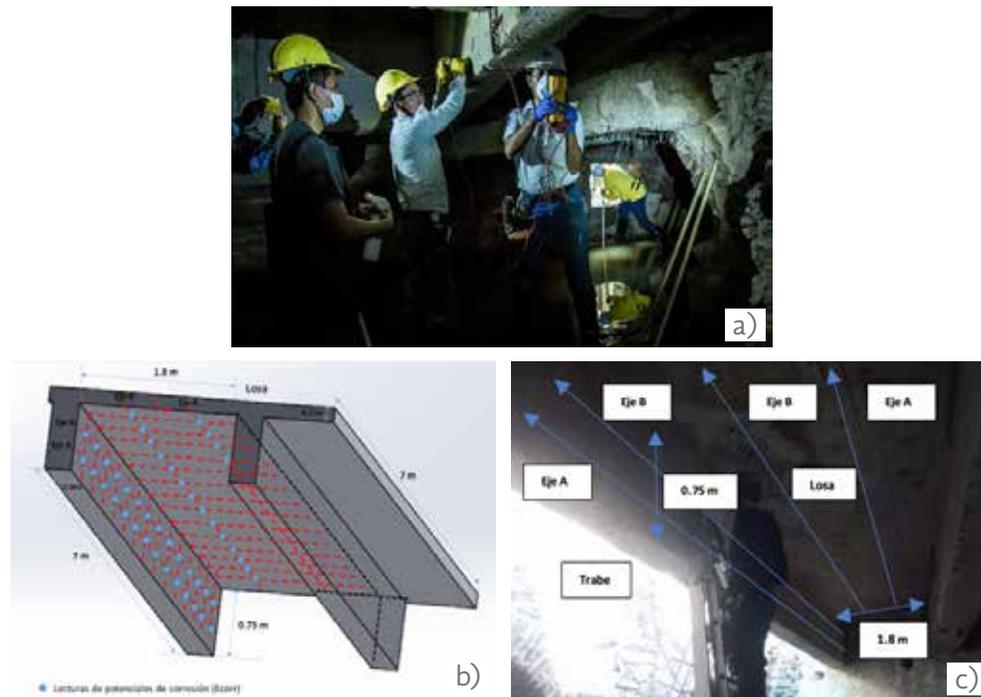
Figure 10. a). In-situ measurements of corrosion potentials (Tavera, 2018), b). Detail of the structure's reading points and c). Measurement axes in slab and beam

A total of 60 electrochemical readings were taken, one measurement every 50 cm, measured longitudinally on the surface of a 180 cm wide and 700 cm long slab section, as well as on a 75 cm depth and 700 cm long beam (Figure 10b and 10c) with corrosion problems. Measurements of the carbonation front were made on several samples of the collapsed concrete slab, using material remains for the carbonation test, in which an acid-base indicator (phenolphthalein) and a transparent millimetric ruler were used (Figure 11).
