STRUCTURAL STRENGTHENING OF A TRADITIONAL ADOBE HOUSE IN CHIAPA DE CORZO, CHIAPAS

Lorenzo Franco Escamirosa Montalvo¹
María de Lourdes Ocampo García¹ and
Roberto Arroyo Matus²

¹Autonomous University of Chiapas, ²Autonomous University of Guerrero

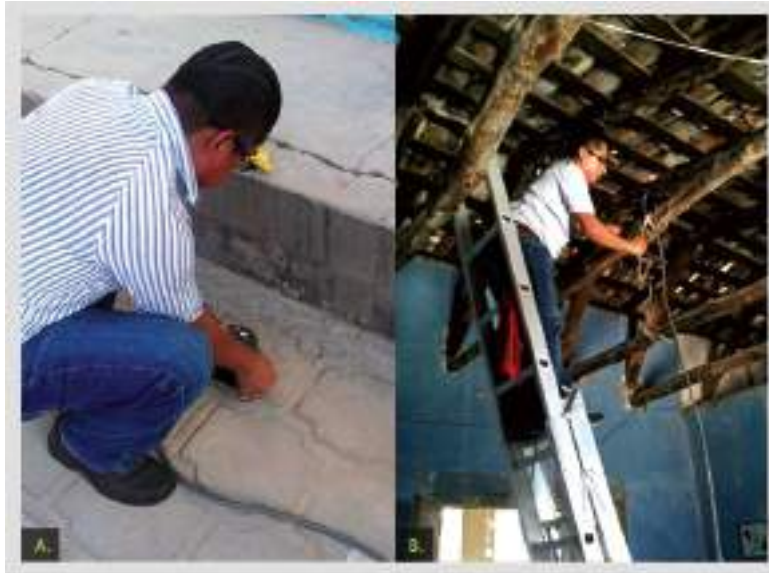
Subsequently the accelerometer was installed in the house to obtain the necessary measurements to determine the fundamental periods of vibration in the house and in the corresponding soil. According to seismograph records stored in 3 orthogonal dimensions of 30 seconds duration each, and based on the calculations of the Fourier spectra in each record, the transfer function, or spectral ratio was established using the Nakamura technique. The results indicate that the fundamental vibration period on average is high: (. Escamirosa, et al, 2013) at 0.2133 seconds in the soil to 0.1506 seconds for the house(Figures 2 and 3).

Figure 2. a)Installing the accelerometer on the floor, b) Installing the accelerometer inside the house

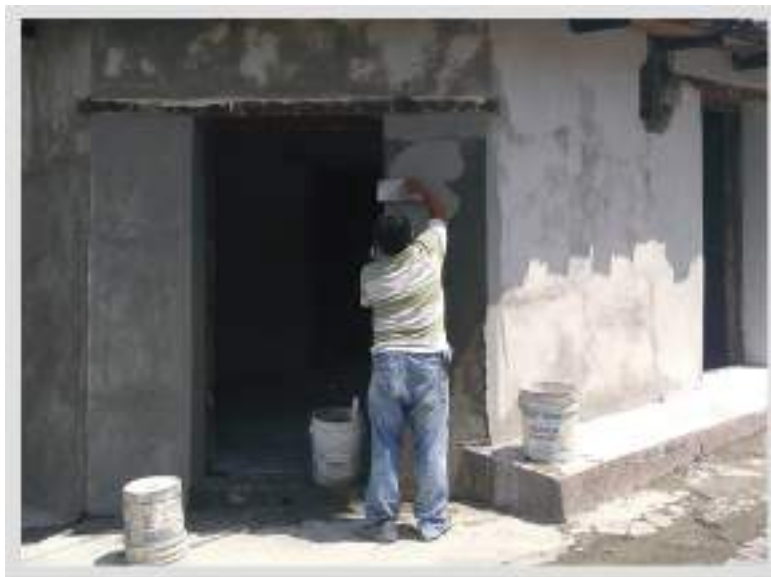
Figure 7. Lime plaster with cement

6. Application of the second layer of mortar: The second layer of cement-sand mortar requires wet walls in order to obtain optimum concrete strength. Like the previous layer, the minimum thickness was 1 cm. (Figure 6).
7. Finished walls: a thin layer of putty produced from cement-lime with a 1:10 proportion was used for the final finish on internal and external walls, like the original caulking on adobe houses (Figure 7).
8. Placement of doors: 3 doors were hung and properly adjusted.
9. Replacement of damaged wood: The wood planks that support the clay tiles were replaced by 1 “x4” pine planks.

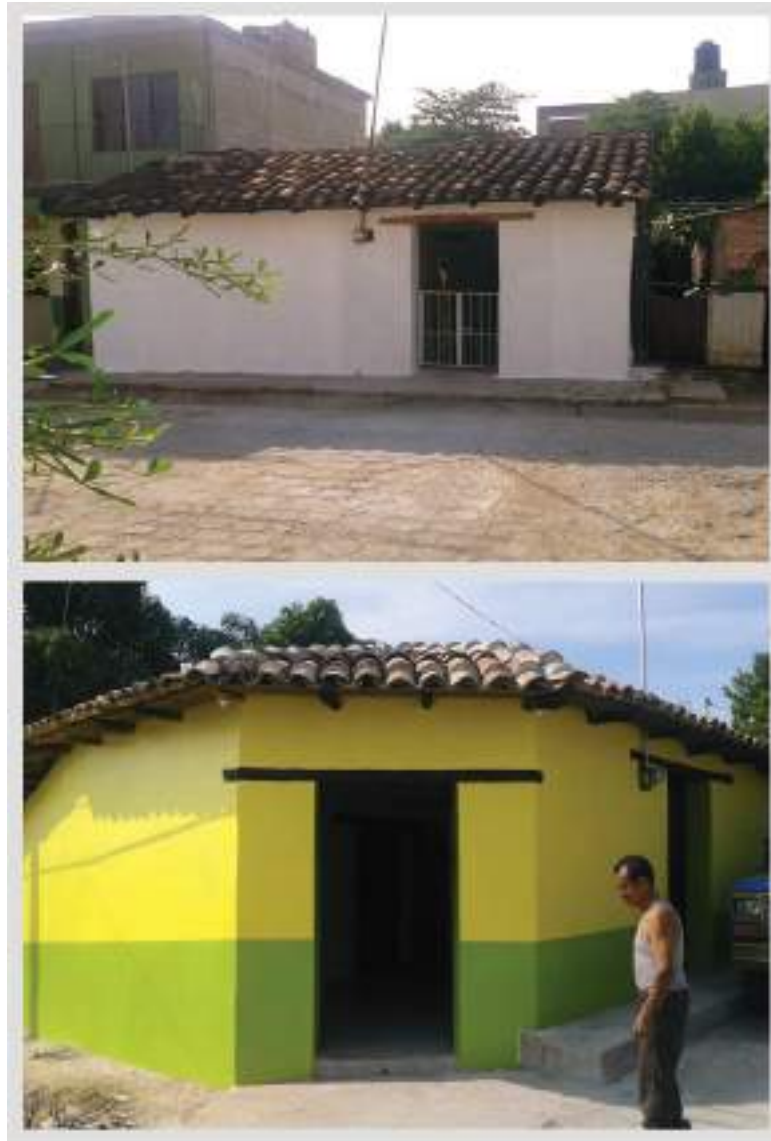
Figure 14. Result of structural reinforcement in housing.

The structural reinforcement was performed in both houses during the months of June, July and August 2014. Following the completion of this work, it is planned in subsequent months the installation of accelerometric instrumentation to perform an evaluation and determine the new periods of fundamental
