ANALYSIS OF THE EFFECT OF WETTING ON THE STABILITY OF A SIDE SLOPE OF THE GRIJALVA RIVER, IN THE STATE OF TABASCO

UNIVERSIDAD JUÁREZ AUTÓNOMA DE TABASCO, ACADEMIC DIVISION OF
ENGINEERING AND ARCHITECTURE, MÉXICO.

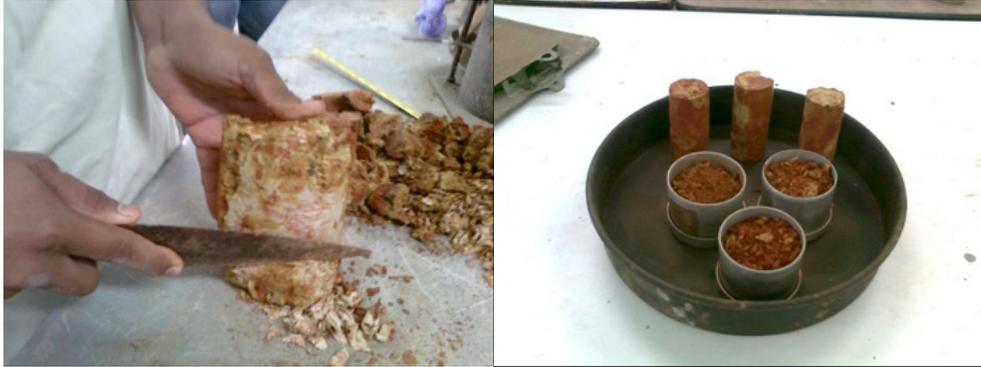
Image 2. Processing of specimens for the triaxial test

Since it is desired to know the evolution of the stability of the riverside as the soil that constitutes it is moistened, it is necessary to know the changes in the magnitude of cohesion as the amount of water increases in the soil. For this, triaxial compression tests were performed on different samples of this soil, varying only its water content. Cylindrical specimens 38 mm in diameter and 76 mm high were carved from the unchanged samples that were extracted during the recognition campaign (Image 2). Sample processing is the process through which, using a minor tool such as knives and cutters, unaltered soil samples (20 cm cubes per side) are obtained from cylinder specimens, in order to perform a laboratory test.

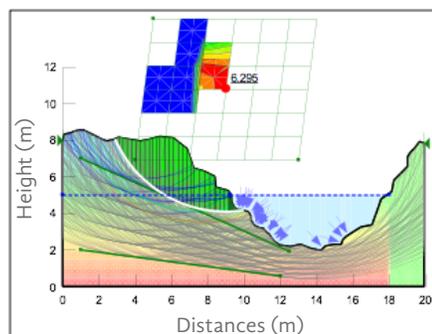
Degree of saturation = 8 %
Cohesion = 57.45 kN/m^2
SF = 6.295

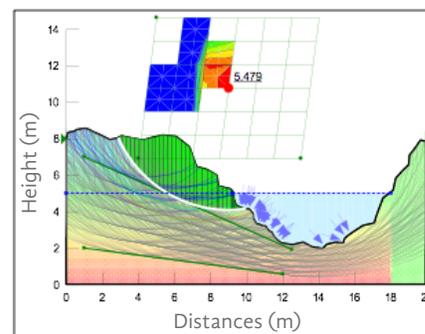
Degree of saturation = 14%
Cohesion = 48.77 kN/m^2
SF = 5.479

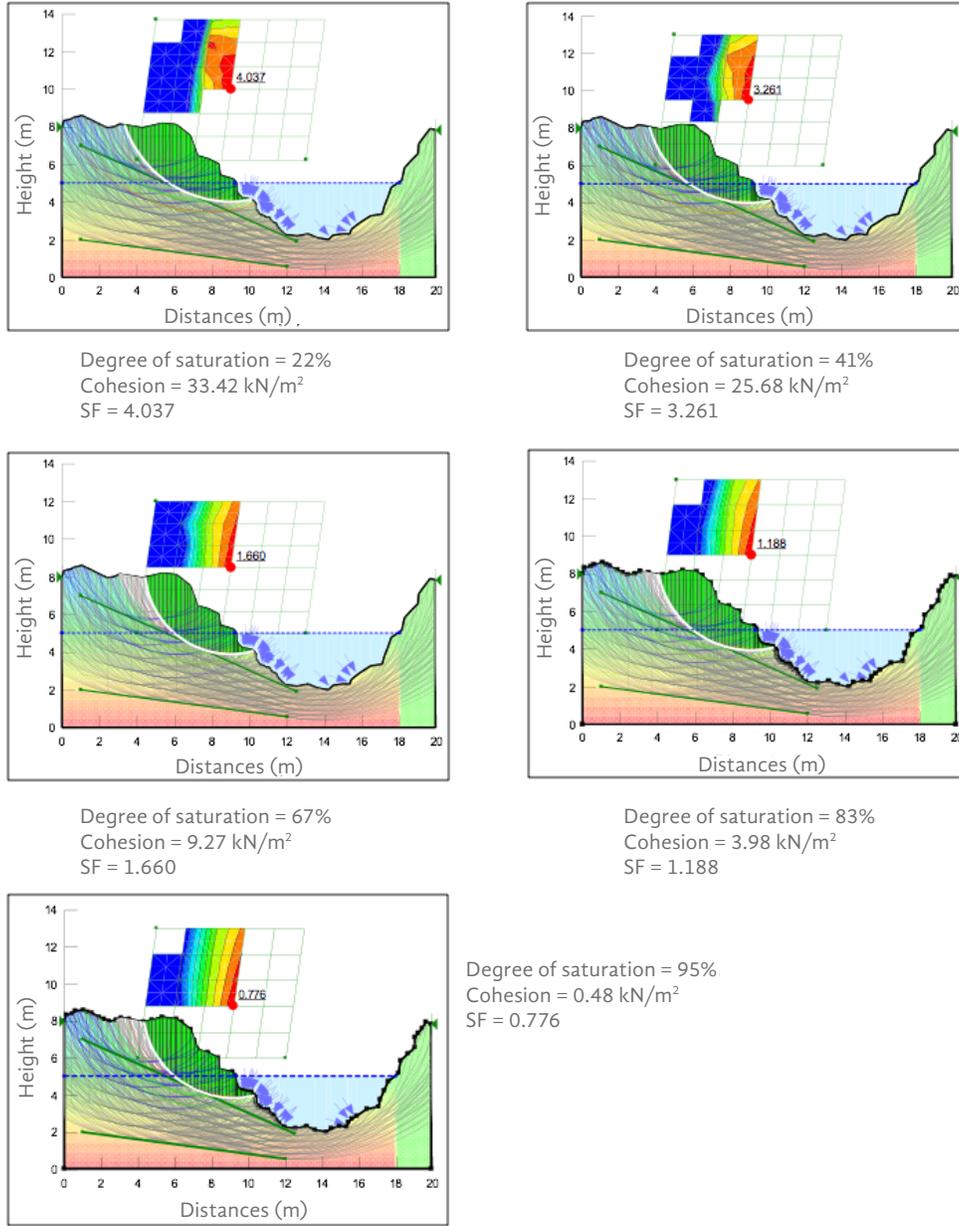
Image 3. Analysis of the bank's stability at different degrees of saturation

Once the edge's geometric information and the soil characteristics were collected, its stability was analyzed. This analysis consists in quantifying the forces that produce instability, as well as those that oppose the failure. The ratio between the forces that oppose the failure and those that cause it, is known as a safety factor (SF) (Juárez y Rico, 2005; Xiao, 2018). If the numerical value of this factor is less than one ($SF \leq 1$), the board is considered to be in fault condition. On the other hand, if it is $SF \geq 1.5$, it is estimated that the bank is safe. If the SF is between the two limits mentioned above ($1 < SF < 1.5$) the edge is considered to be at risk. The method used in this investigation to calculate the SF was the Fellenius method (Juárez and Rico, 2005). This method has been extensively studied, and implemented in analysis of soil slopes, and has shown excellent performance. Image 3 shows the stability analysis of the edge for different cohesion values shown in Table 2. In each analysis a mesh is observed in which the minimum value of the SF is shown. According to Image 3, the highest safety factor corresponds to the highest cohesion condition, that is, to the driest bank. It can be seen that as the degree of saturation increases in the constituent floor of the bank, the safety factor decreases (Image.4). It can be seen, in the results obtained, that the stability of the bank is guaranteed ($SF \geq 1.5$) as long as the degree of saturation of the soil that composes it is less than 70% (Image 4).

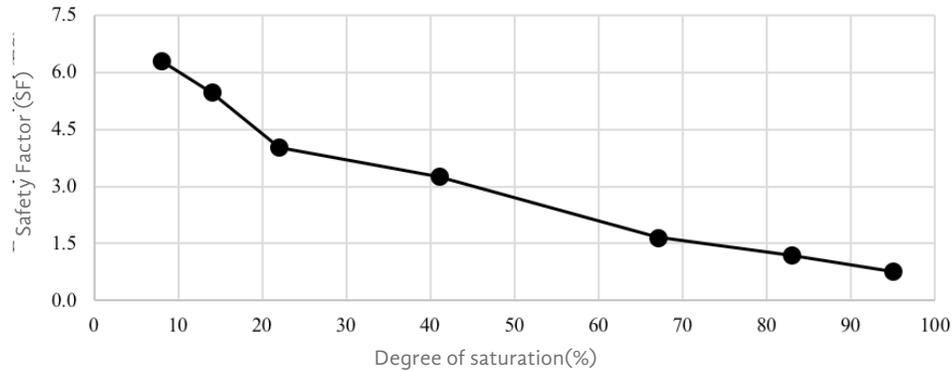
Image 4. Evolution of the safety factor with changes in the degree of soil saturation

- If rainfall is sufficient to place the soil's degree of saturation between 70% and 85%, the bank is in a situation of risk of failure ($1 < SF < 1.5$);
- If the dampening of the edge places the saturation level above 85%, the bank failure will occur ($SF \leq 1$).

The results found in this investigation have shown that the progressive moistening of the constituent soil of the bank studied causes a decrease in the safety factor. After the flood in the state of Tabasco that occurred in 2007, it was necessary to repair 43 edges located only in the capital of Tabasco. The above represented an investment of 152.4 million pesos. The following year, after an intense period of rains (October-November), 53 edges were repaired, this time at a cost of 200 million pesos (Marí, 2009). The results obtained in this investigation show (at least for the bank under study) that when the soil reaches a degree of saturation greater than 85%, its stability is at risk. Achieving this degree of saturation in the state of
