PROPOSAL FOR ALTERNATIVE
HOUSING WITH THREE-CELL
MORTAR HOLLOW BLOCK WALLS,
FOR LOW-INCOME FAMILIES. CASE
STUDY: COPAINALA, CHIAPAS,
MEXICO

FACULTAD DE ARQUITECTURA DE LA UNIVERSIDAD AUTÓNOMA DE
CHIAPAS. MÉXICO

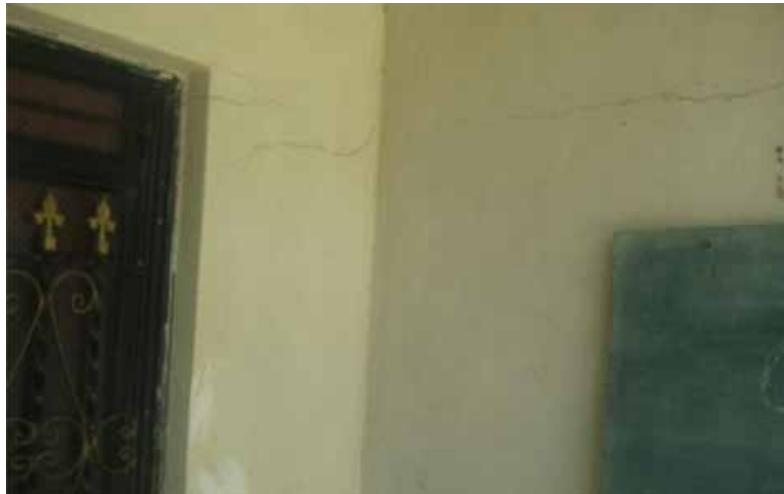
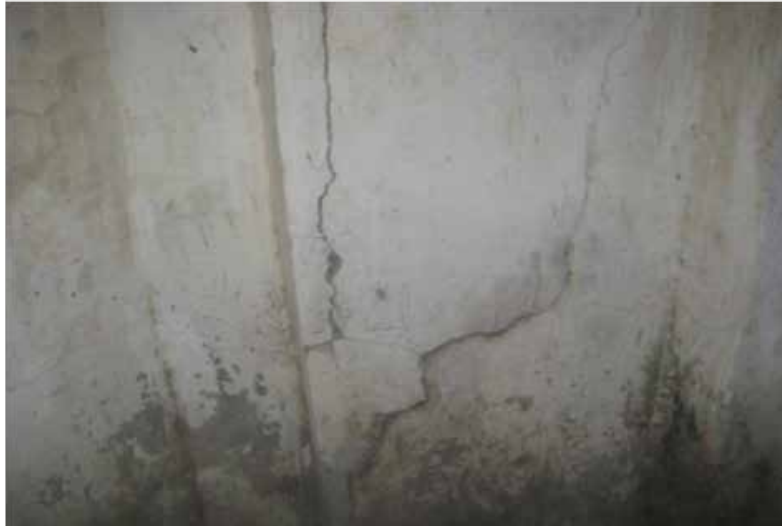
Image 5. Cracks at the intersection of walls

Image 6. Cracks at the intersection of walls

In Images 5 and 6, we can see wall cracks of houses built with pieces of two-cell hollow mortar blocks, specifically in the upper part of the intersection, on door and window openings, and on the lower part adjacent to the floor of house walls. This is a consequence of the lack of structural confinement, since it was observed that vertical reinforced concrete elements (castles) were only built at intersections of walls and vertical reinforcement in door and window openings was omitted (Images 7 and 8).

Masonry walls of analyzed houses, built with hollow mortar blocks, in addition to existing vertical and horizontal reinforcement (castles and chains), must necessarily have additional structural reinforcement inside cells, in both directions, as established by the *Normas Técnicas Complementarias para el Diseño y Construcción de Estructuras de Mampostería* (NTC, 2017). For this reason, and due to poor quality of dwellings construction, as well as the presence of various wall cracks and failure to comply with the minimum regulatory requirements for safe and durable buildings, it is noted that analyzed dwellings are vulnerable to the effects of seismic movements and, therefore, there are possible risks that do not guarantee their occupants' safety.

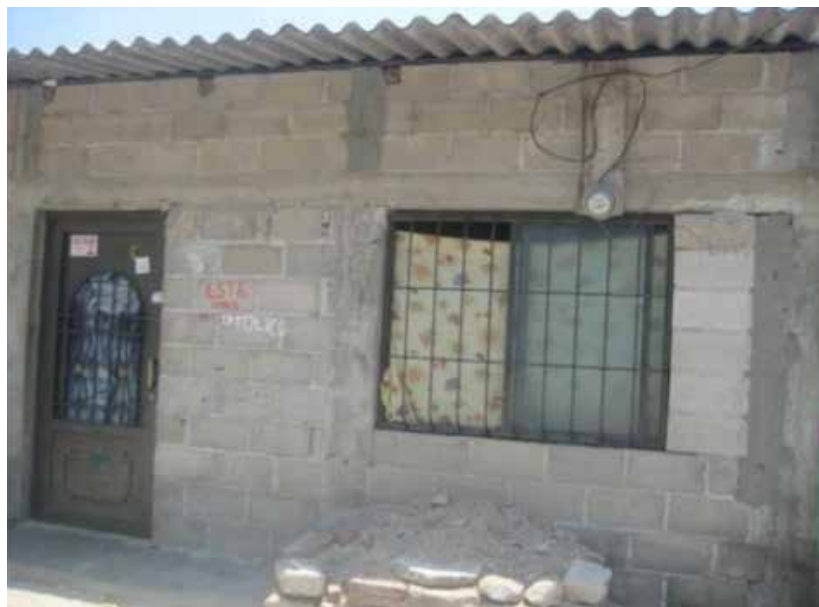
Image 7. Absence of vertical reinforcement in openings. Source: Own elaboration

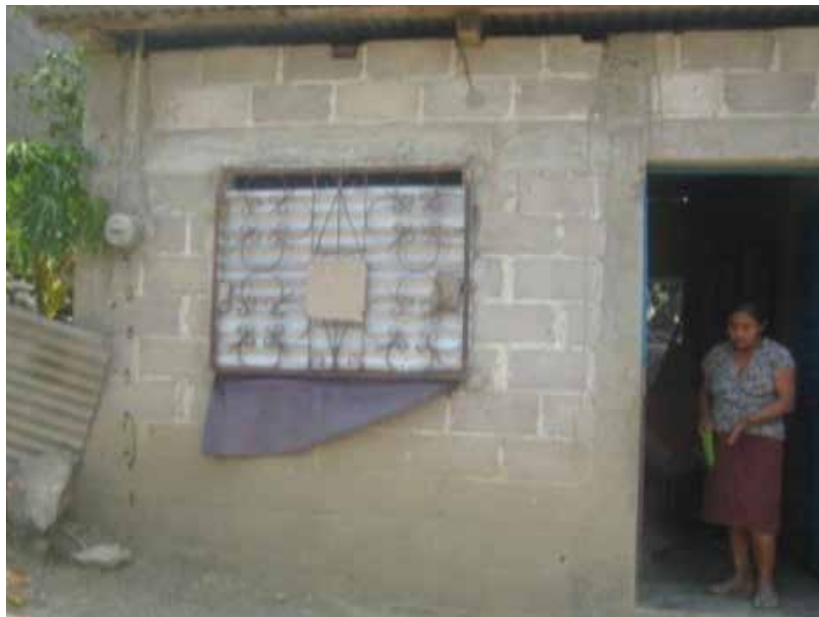
Image 8. Absence of horizontal reinforcement in window. Source: Own elaboration

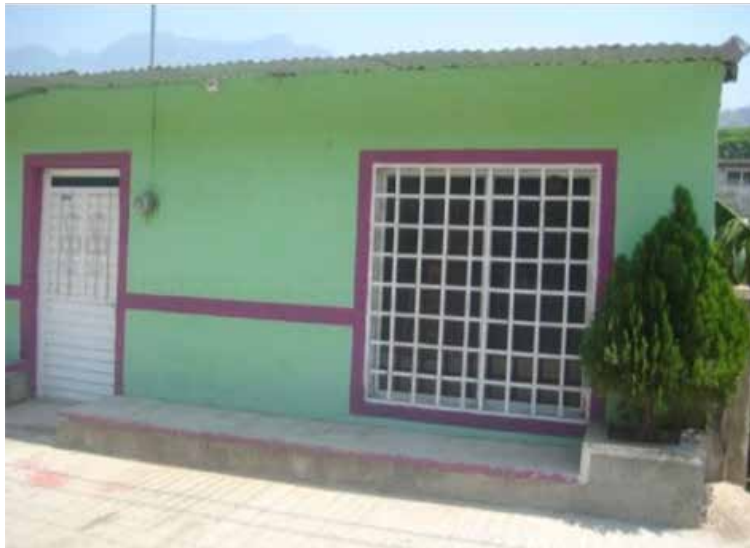
The rectangular shape of dwellings analyzed is predominant, with dimensions that vary between 7 to 8 m in front and 5 to 6 m on each side, with a construction area of less than 50 m². The facades have an average height of 3 m, are rectangular and above the door and window openings, a solid stands out. The windows are generally square, 1 m per side; however, in very specific cases, windows measuring 1.5 x 2.0 m were found. The roof is gabled and predominant roofing system is zinc sheet, followed by clay tiles. Interior and exterior walls of the majority of the houses do not have covering (finish), which allows us to appreciate the poor quality of labor used; it is also observed that floors are made of concrete with a polished finish in gray and walls are painted with bright colors and, in some cases,

borders and skirting board are defined with contrasting colors, in search of an identity that is expressed in the images (Images 9 and 10).

Image 9. Facade of a dwelling at street level. Source: Own elaboration

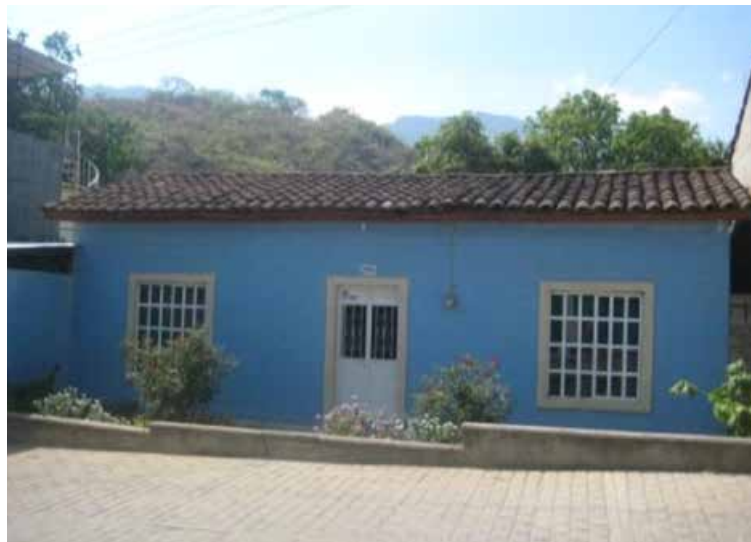
Image 10. House with a small garden. Source: Own elaboration

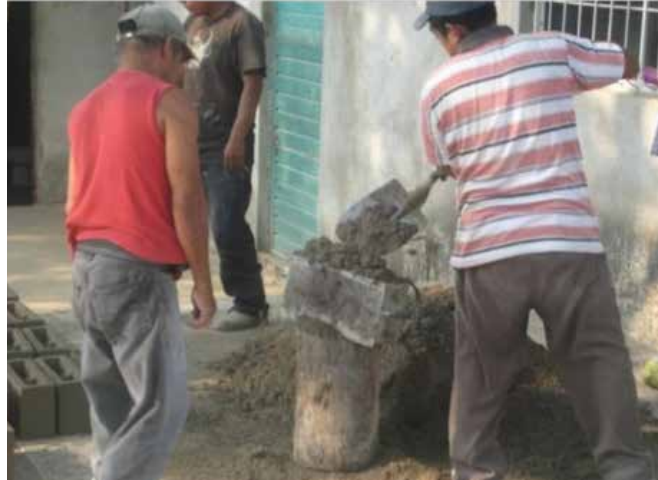
Next, the mortar was poured into the steel mold and the material was compacted with a wooden bar; furthermore, on one occasion, the mold was raised to approximately 30 cm and dropped to achieve better compaction; then, missing material was added to the mold and the bar was again used

Image 11. Block processing. Source: Own elaboration

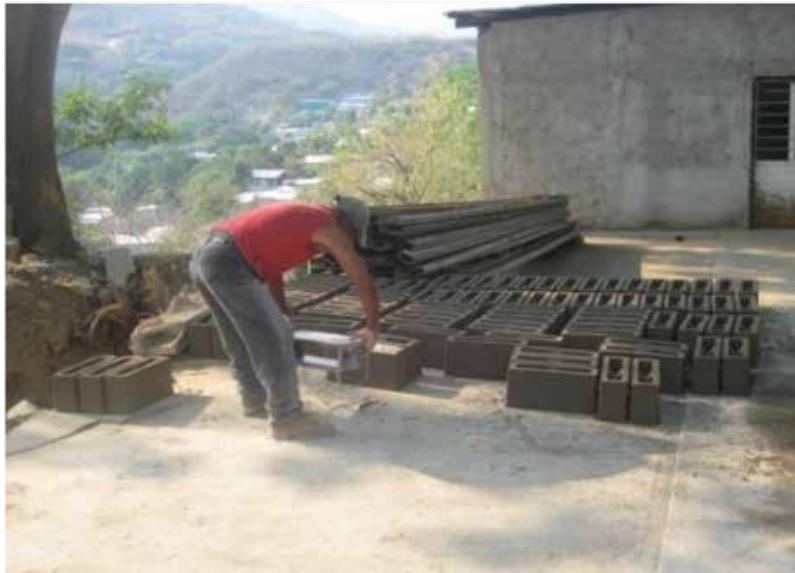
Image 12. Storage and drying. Source: Own elaboration

In the drying area, the mold was rotated 180° and slowly removed vertically. There, the block was left to dry and rest on drying surface for two days and then stored or used immediately in construction. Obtained pieces were 12 x 20 x 40 cm (12 cm wide, 20 cm high and 40 cm long) (Image 12).

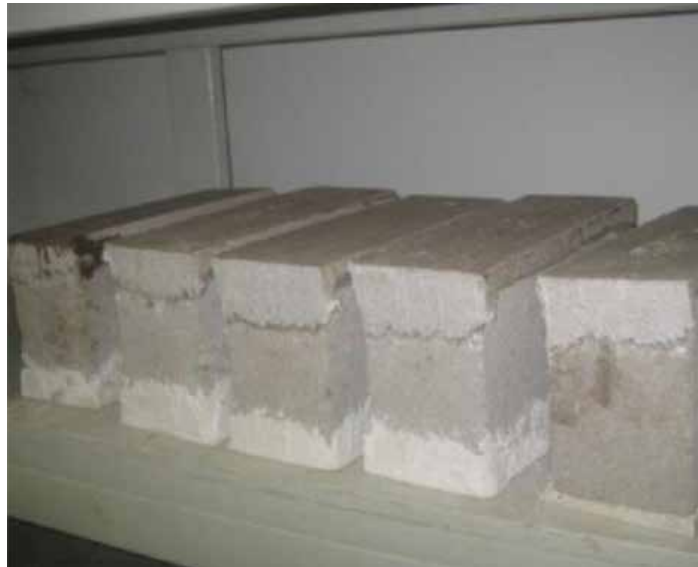
Prior to resistance test, each piece was pitch tested to create a uniform surface, on both sides and with 48 hours of drying, before being placed in the machine and performing the compression test (Image 13).

Image 13. Pitching of the mortar blocks. Source: Own elaboration

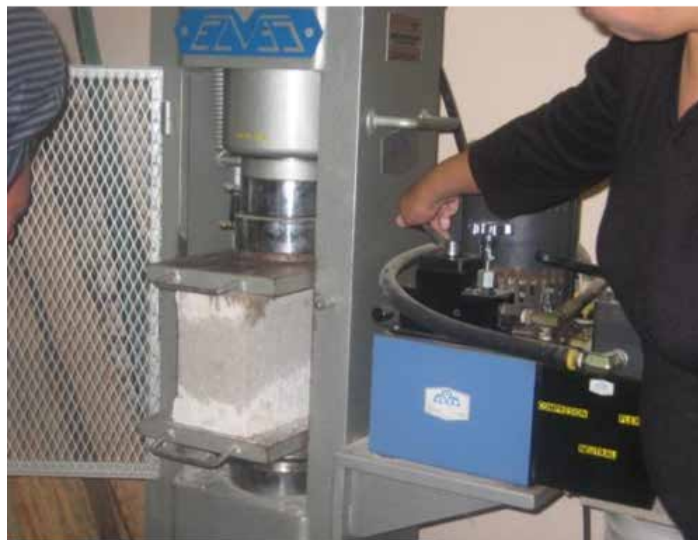
Image 14. Compression test. Source: Own elaboration

- Finally the test was executed and an average compression resistance of 41.45 kg/cm^2 was obtained. Tests were carried out in an Elvec digital electric press with a compression frame of 120,000 kgf. In each test the load was applied with uniform and continuous speed, without producing impact nor loss until reaching failure by the maximum load applied to the specimen, which was divided by net area to determine compression resistance. In this regard, the standard (NMX-C-404-ONNCCE-2012) specifies that minimum compression resistance of block must be 70 kg/cm^2 ; which means that this standard was not met (Image 14).

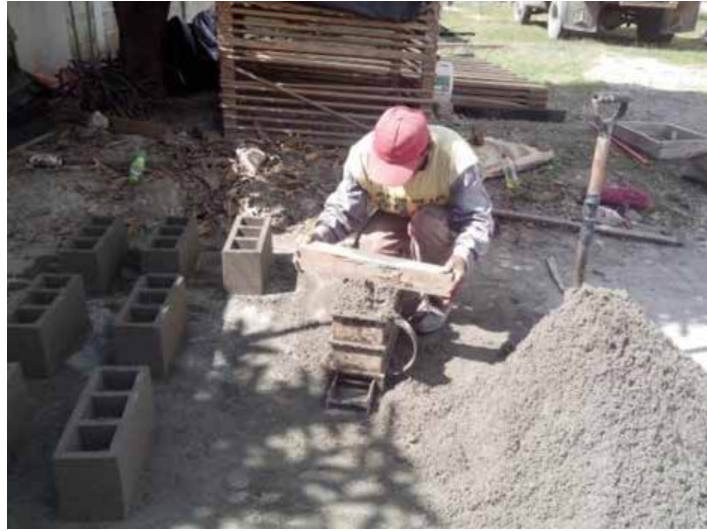
- Homogenization: Materials were mixed, cement-sand, and water was added.
- Blocks manufacture: The mixture was poured into the mold and compacted with the help of a bar. Then, the mold was raised with handles and dropped freely three times, to achieve greater mixture compaction and avoid gaps inside the mold, then removed excess mixture with the bar. With this process, the density of the pieces was increased and, therefore, greater resistance was obtained. In the elaboration of the pieces in the locality, to compact the mixture, only the mold containing the mixture was dropped freely, on one occasion only (Images 16 and 17).

Image 16. Block manufacturing process. Source: Own elaboration

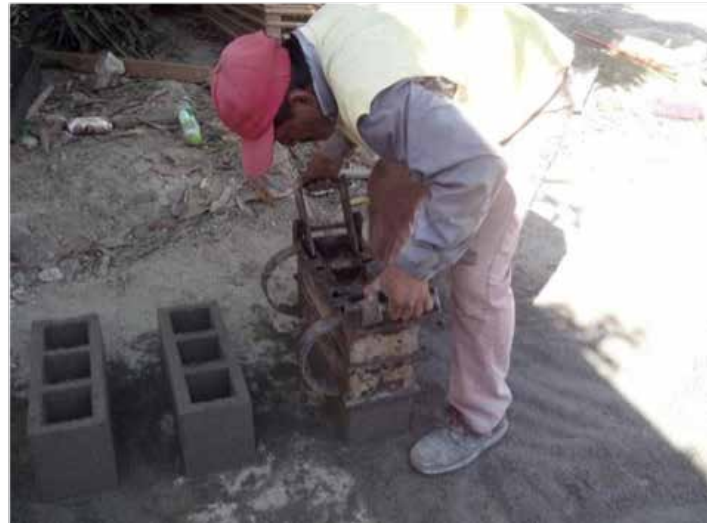
- Storage and drying of the pieces: On site, the mold was removed and the pieces were obtained, which were then left to dry and, after three or four hours, the concrete was cured for six days. This curing process (wetting of blocks) was not carried out in the town's pieces production.

Image 17. Mold Removal Process. Source: Own elaboration

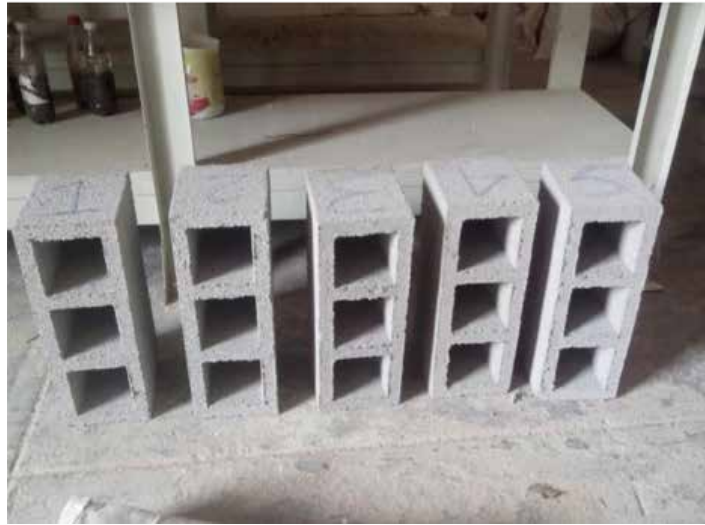
After the necessary time for the mortar blocks to reach maximum resistance, compression and absorption resistance tests were carried out; five pieces were selected at random and tested in the laboratory. In the first stage, each piece was recorded and characteristics of the 5 specimens were measured; average dimensions were 15x19.1x40 cm, average net area was 51% of the gross area, which is equivalent to obtaining an average net area of 306.04 cm²; likewise, each specimen was weighed and the average weight was 11.48 kg (Images 18 and 19). Then, absorption test was performed, obtaining an average absorption of 8.55%, which is within the range established in the standard (NTC, 2017). In the second stage, the compression test was performed on each specimen and average compression resistance of 48.70 kg/cm² was determined.

Image 18. Registration of the pieces of the block. Source: Own elaboration

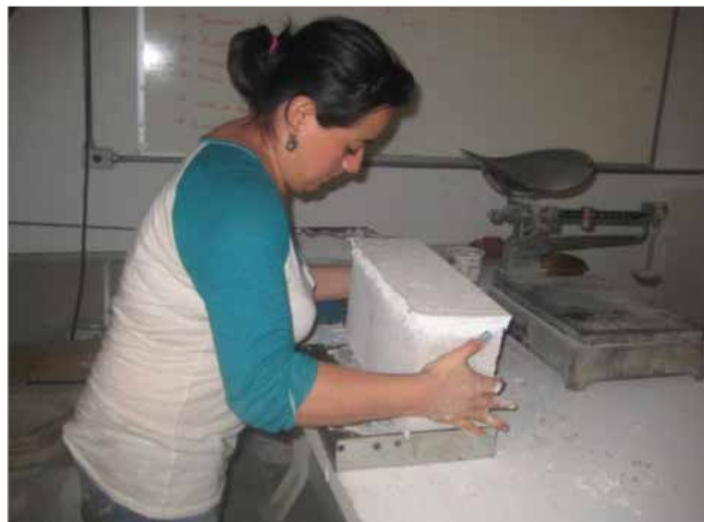
Image 19. Pitching process. Source: Own elaboration

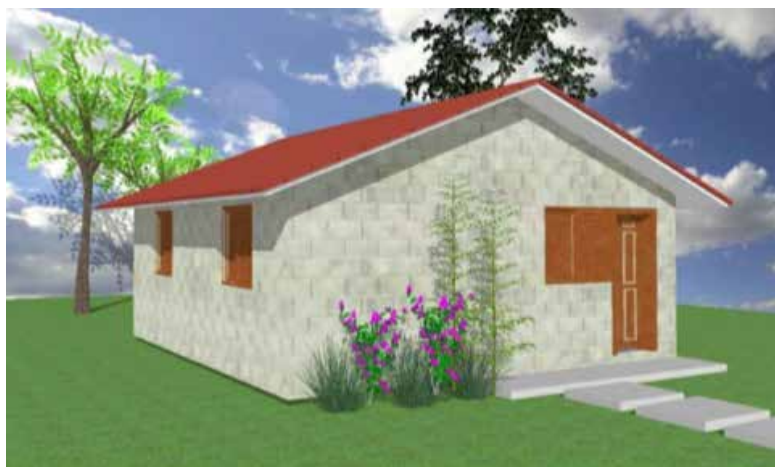
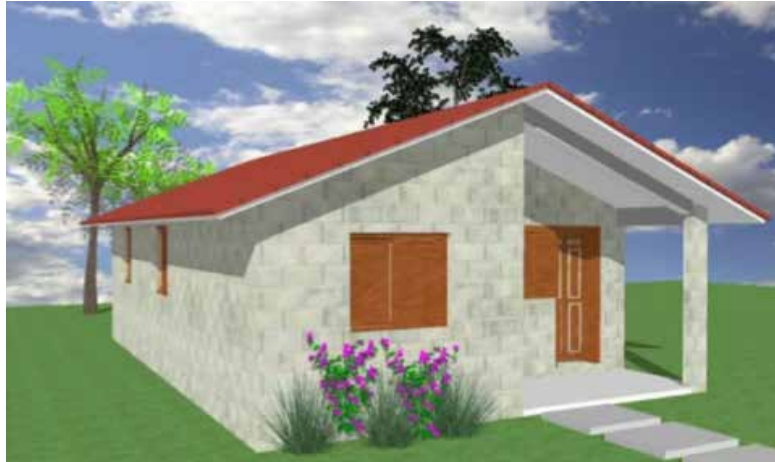
This housing, is proposed for families of 2 up to 5 members, from a compact model with a surface of 36 m², and it is developed in a plant, organized by two bedrooms, stay, dining room, kitchen and bath; later, the option to extend housing is available, in agreement with the family's economic possibilities. Extension in a future growth is given in the front part of this one, where it is considered the access porch that distributes towards the housing interior. Future growth consists of a bedroom and the extension of spaces in the living and dining room (Plans 1 and 2; Images 20 and 21).

Plan 3. Architectural Floor Model "A" (Starting house). Source: Own elaboration

Plan 4. Architectural Floor Model "A" (Future horizontal growth). Source: Own elaboration

Image 20. Model "A" perspective (Starting house). Source: Own elaboration

Image 21. Model "A" perspective. (Future growth) Source: Own elaboration

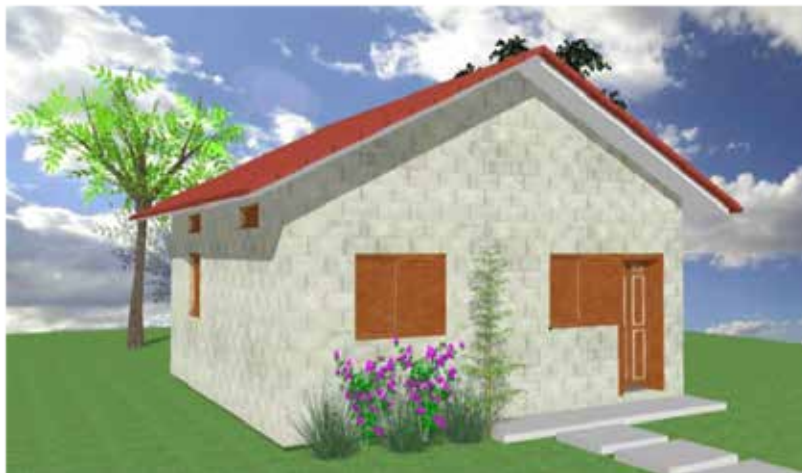
The second proposal is similar to the previous one, in terms of space and distribution of the starting house. For future growth, a double height (mezzanine) is considered. In the access there is a staircase that leads to the mezzanine that considers the space for two more rooms. Ground floor is distributed with a living-dining room and kitchen, with open spaces and two bedrooms. The bathroom module is the only one that is closed. The proposed construction elements are the same as model "A". However, in this model, a higher height in the walls for wall covering and with the roof sloping to two waters is considered (Plans 3 and 4 and Image 22).

Plan 1. Architectural Floor Model "B" (Starting house) Source: Own elaboration

Plan 2. Architectural Floor Model "B" (Future horizontal growth) Source: Own elaboration

Image 22. Model "B" perspective (two floors) Source: Own elaboration
